# Charmy Down Farm Nr Bath The Lodge

## Structural Commentary

Project Number: 5680

Date: December 2012

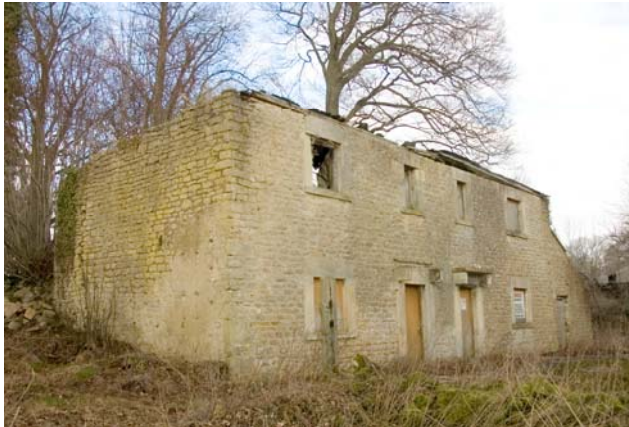
February 2010 - South & West Elevation

2.04 The south and west elevations do not appear to have deteriorated significantly between 2008 and 2012 with the above noted defects remaining largely unchanged. The structures to the east and the north elevation, however, have suffered degradation in this period. This is primarily due to the ongoing vegetation growth in the form of ivy and shrub and tree growth, as well as damage to the masonry due to the core of the walls being unprotected from the weather. This has resulted in the core of the wall getting saturated which, coupled with the harsh winters of recent years, has accelerated the decline in the structural condition of these elements largely due to frost action expanding the saturated mortar and thus breaking the bond with the surrounding stonework. Over time the end result unfortunately is wall failure as illustrated below.

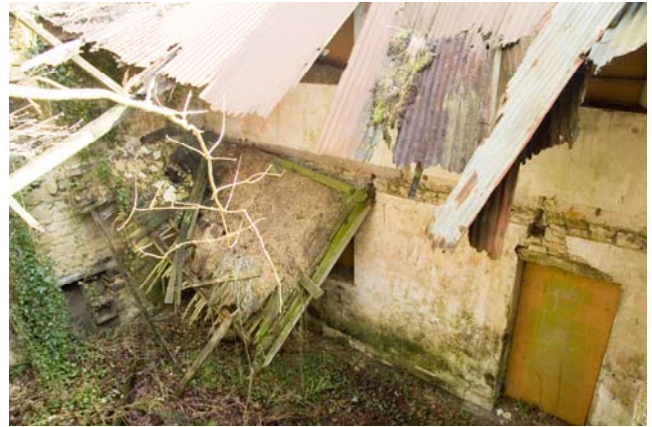
February 2010 – Collapsed Roof Structure

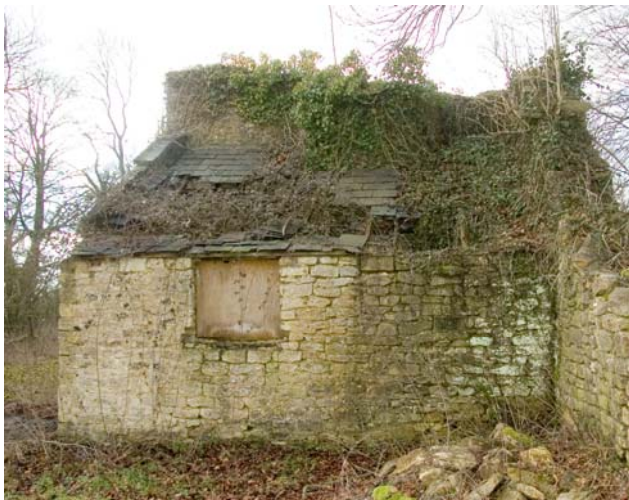
February 2010 – East 'Lean To' Structure

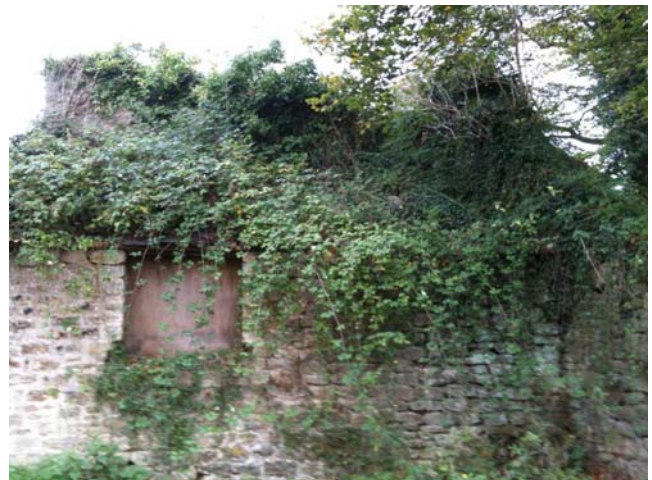
October 2011 – East 'Lean To' Structure

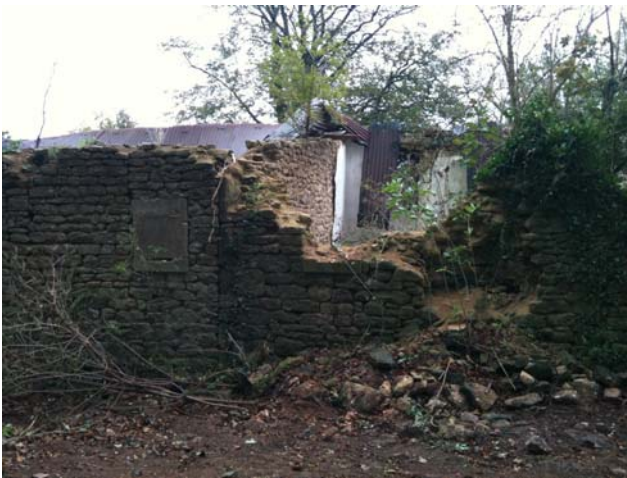
2.05 Below is a photo taken in October 2011 just before the section to the back and right of the collapsed section illustrated, gave way in December 2011 following a period of bad weather exposing the core to the lower wall in the area of the former fireplace.

October 2011 - North Elevation

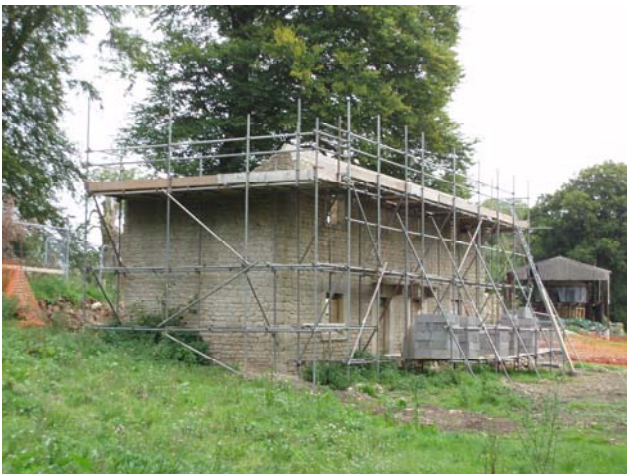
September 2012 – South & West Elevation

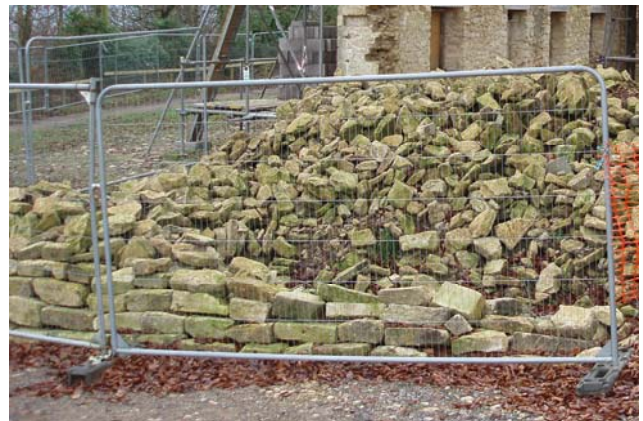
September 2012 – Stone set aside for re-use

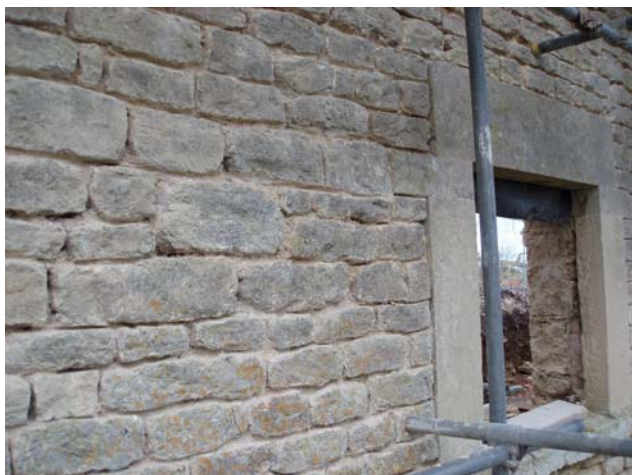
September 2012 - Raked out bed joints

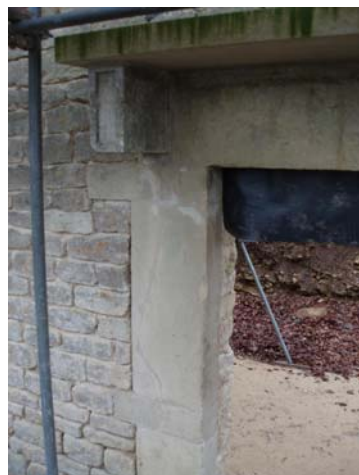
September 2012 – Repaired Door Reveal

- 2.14 The condition of walls A and B have been found to be very good and the fractures to the wall and stonework in the south façade have been successfully repaired to a very good standard by careful masonry work.

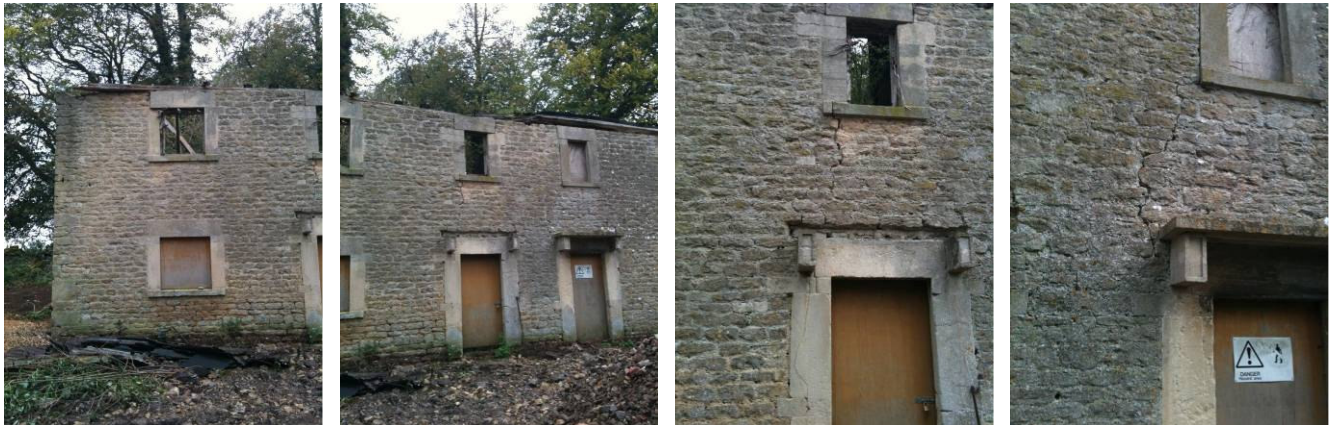
The front (south elevation) remains intact virtually up to roof eaves level, but clearly the masonry at the head of the walls and the lintels to the windows have suffered from moisture ingress and vegetation growth and the masonry is very loose.

There are currently two entrances into the building at ground floor level and above each entrance there are vertical fractures indicating structural movement is occurring to the elevation. The elevation remains quite plumb but the fracturing would indicate that there may be some issues with either the foundations or the lack of lateral restraint to the walls (refer later).

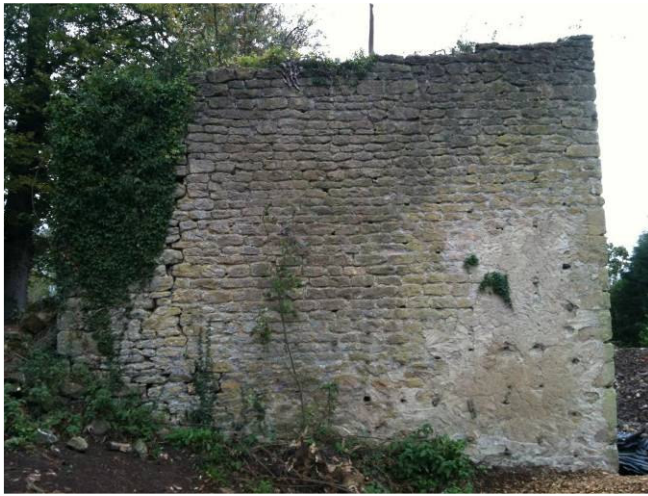
West Elevation

The west elevation again appears reasonably plumb but there is a large vertical fracture at the northern end again indicating either foundation problems or a lack of lateral restraint. The masonry to the head of this wall is also loose and there is currently no protection against the ingress of water into the head of the wall.

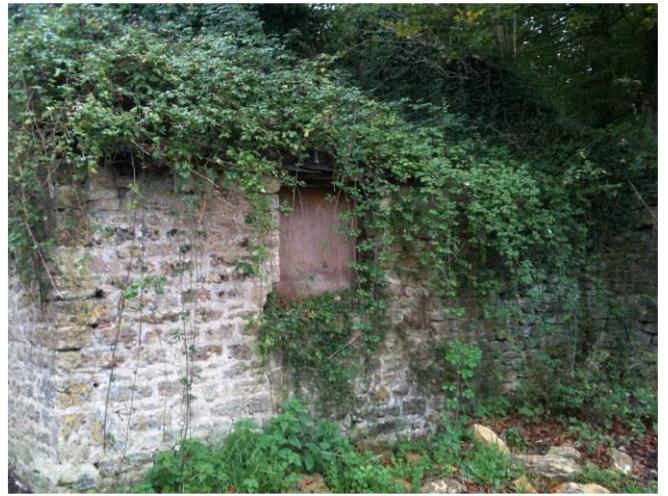
East Elevation

This elevation comprises a single storey lean to built up against the two storey gable end. The gable end has an integral chimney structure but at the time of the survey this end of the building was largely covered in vegetation. From what could be seen this end of the building is suffering from similar issues to the other elevations in that the masonry to the head of the walls is loose and currently there is no weather protection to these areas.

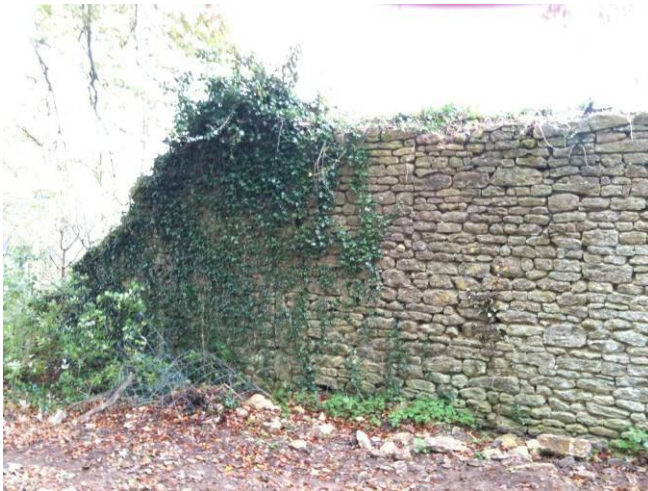
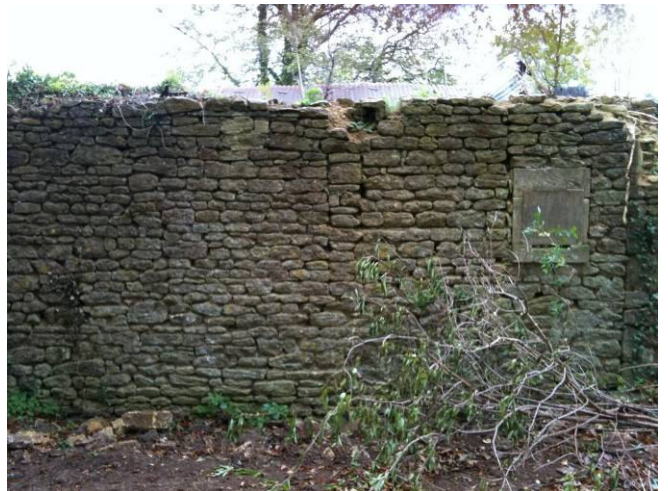
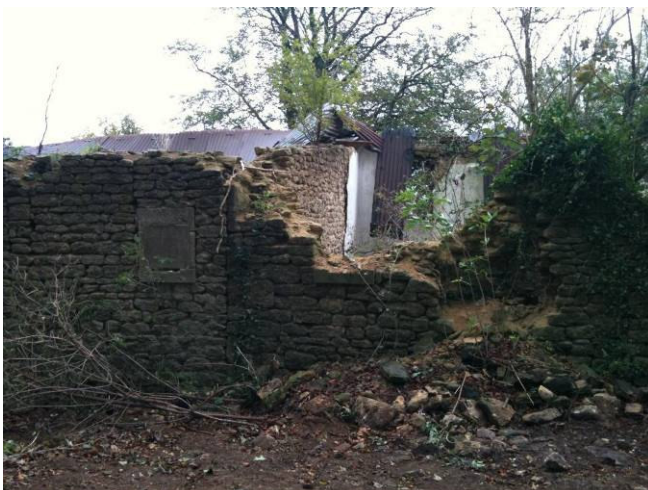
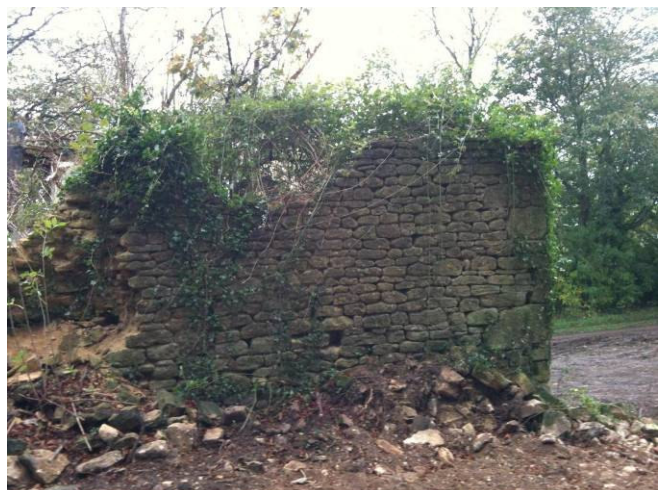
North Elevation...

The north elevation is in poor condition. The eastern end leans outwards and the masonry is loose, a section in the centre west has collapsed and the western end has a lot of vegetation growing out of it and the corner is very loose. There is also a straight joint in the centre which does not help the stability of the wall at this point.

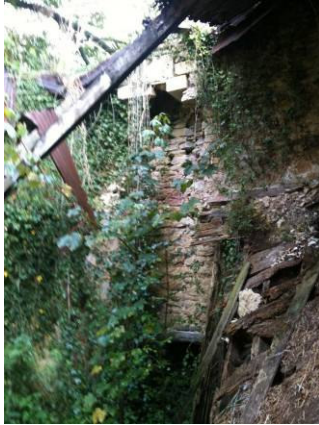
Originally there would have been a timber floor internally comprising timber beams and floor joists, but this has completely collapsed. Likewise it appears the building recently had a mono pitch corrugated iron roof supported on purlins but this too has completely collapsed.

Collapsed Roof and Floor

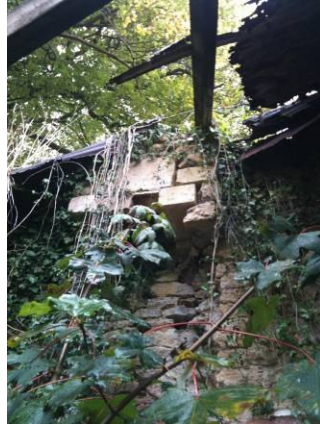
Collapsed Chimney Brest

There is also an old chimney breast in the western portion of the building but this has largely collapsed and needs rebuilding.

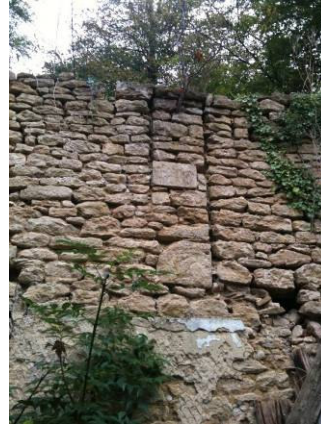
Vegetation Growth/Open Jointing

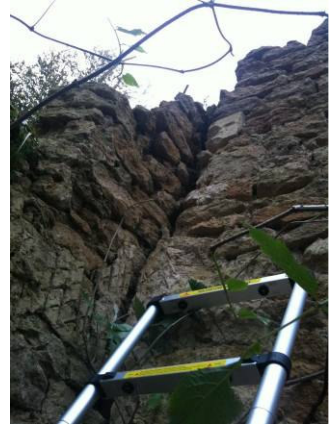
Straight Joint

The internal cross wall and the rear walls in particular appear to have a number of straight joints in them which are not ideal bearing in mind the general condition of the building.

The masonry to the head of the walls is very loose and there is currently no protection to the walls from the weather. This situation has clearly remained so for a long time as the walls are quite voided and a lot of the mortar to the walls has washed out. The weathering has also resulted in the plaster to the rear and side walls falling off. The face of these walls therefore no longer has any protection against the weather and no longer has the plaster bonding the masonry face together. The straight joints in the walls need stitching across to reinstate some tying together of the structure.

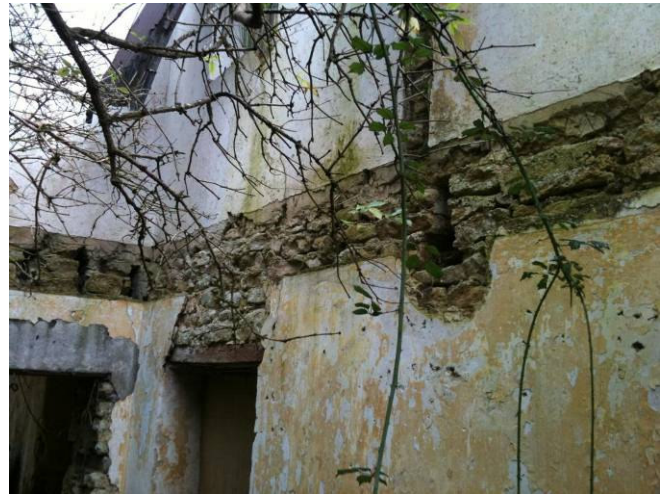
Wall Sockets For Joists/Beams
