# Charmy Down Farm Nr Bath The Lodge

## Structural Commentary

Project Number: 5680

Date: December 2012

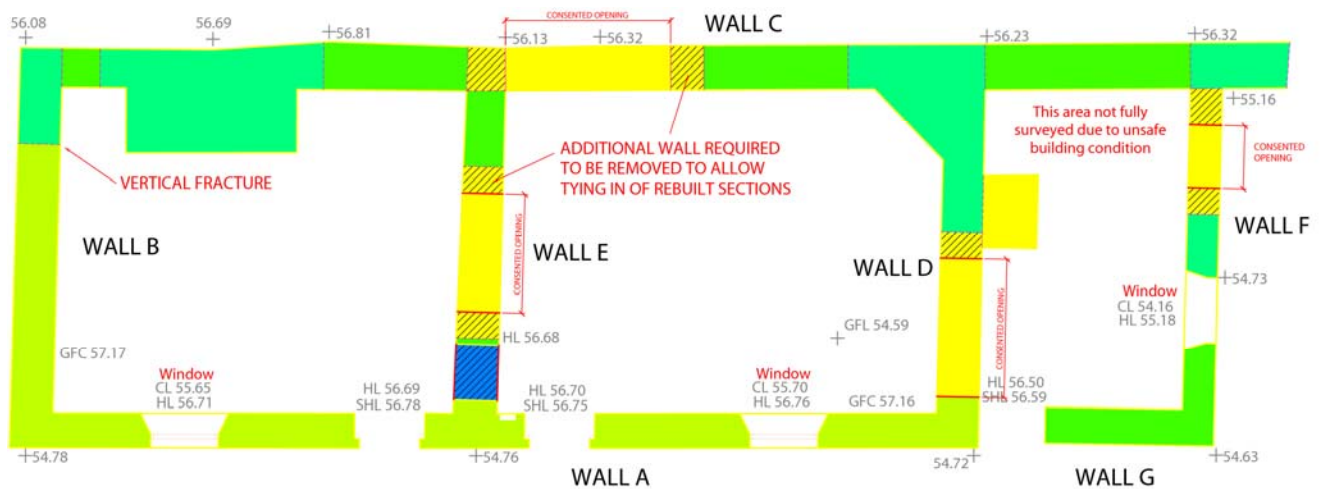
Extract From Drawing 5680\_L01 in Appendix A

2.08 The external chimney flue on wall D was consented to be removed but on removal of the chimney stonework masonry in a very poor condition was revealed on the east side of wall D clearly due to the ingress of water and vegetation growth over a number of years. The masonry behind the chimney flue in the north east corner was also found to be in very poor condition. Having found the centre and north end of wall D in a very poor state of repair it was decided that in order to safely create the consented opening at ground floor level the only option that could safely be adopted was to carefully take down the east end wall, setting aside the masonry for re-use, and to rebuild it with properly formed reveals to the new openings.

- 2.09 Wall C had a lot of vegetation growing over and through it and it was recognised that this wall needed to be carefully dismantled down to first floor level early on in the process. The consented works included the formation of a stair 'turret' in the north wall and the retention of the fireplace in the westernmost cottage at ground floor level. The wall collapse in December 2011 and subsequent clearing of failed masonry and vegetation revealed that the front face of the wall where the fireplace was located had fully collapsed leaving only the outer skin of masonry in place. In order to repair the masonry in this location the only course of action was to take down the remaining masonry and build it back up off the existing foundation (if found to be suitable to do so).

- 2.10 The fireplace was immediately adjacent the north end of wall B which had a vertical fracture through it at the northernmost end. The formation of the stair turret necessitated the removal of the centre of wall C which, coupled with the required rebuilding of the wall to the rear of the fireplace, meant a long section of the rear wall needed rebuilding from ground level upwards. This rebuilding would have left short sections of wall that in theory could have been retained, notwithstanding the health and safety issues working around an unrestrained wall of unknown integrity, the fact the north end of wall B had a large vertical fracture and needed rebuilding itself, coupled with the fact the junction between wall D (removed due to poor condition) and wall C was in very poor condition due to long term degradation of the masonry to the corner chimney flue, resulted in a decision being made to carefully take down the whole of the north wall down to ground level and rebuild it using the stone reclaimed from the dismantling of the wall.

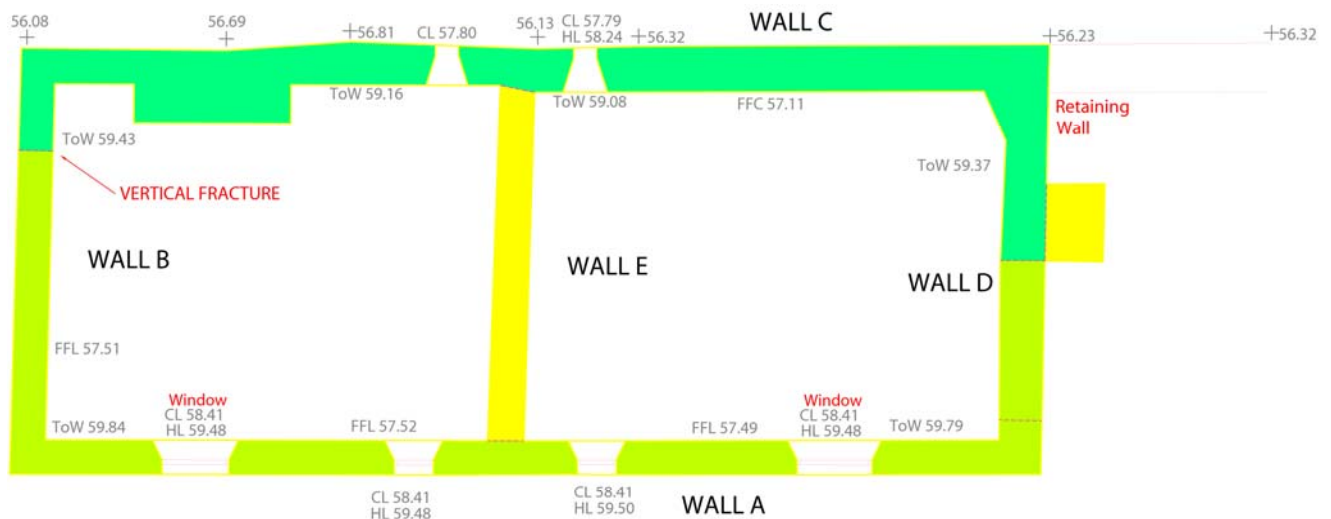
Extract From Drawing 5680\_L01 in Appendix A

- 2.12 Similarly walls F and G to the lean to were in a poor state of repair above door head level on wall G and at the north end of wall F where a new opening was proposed. Only the southeast corner of these walls remained in a condition suitable for retention but, as a result of the works outlined above, it was decided that this section too would be best rebuilt.

- 2.13 As a result of the above sequence of events only wall A and wall B remain as the condition of portions of the remaining walls, coupled with the consented alterations, meant that these walls were taken down with a view to them being rebuilt utilising reclaimed stonework where possible.

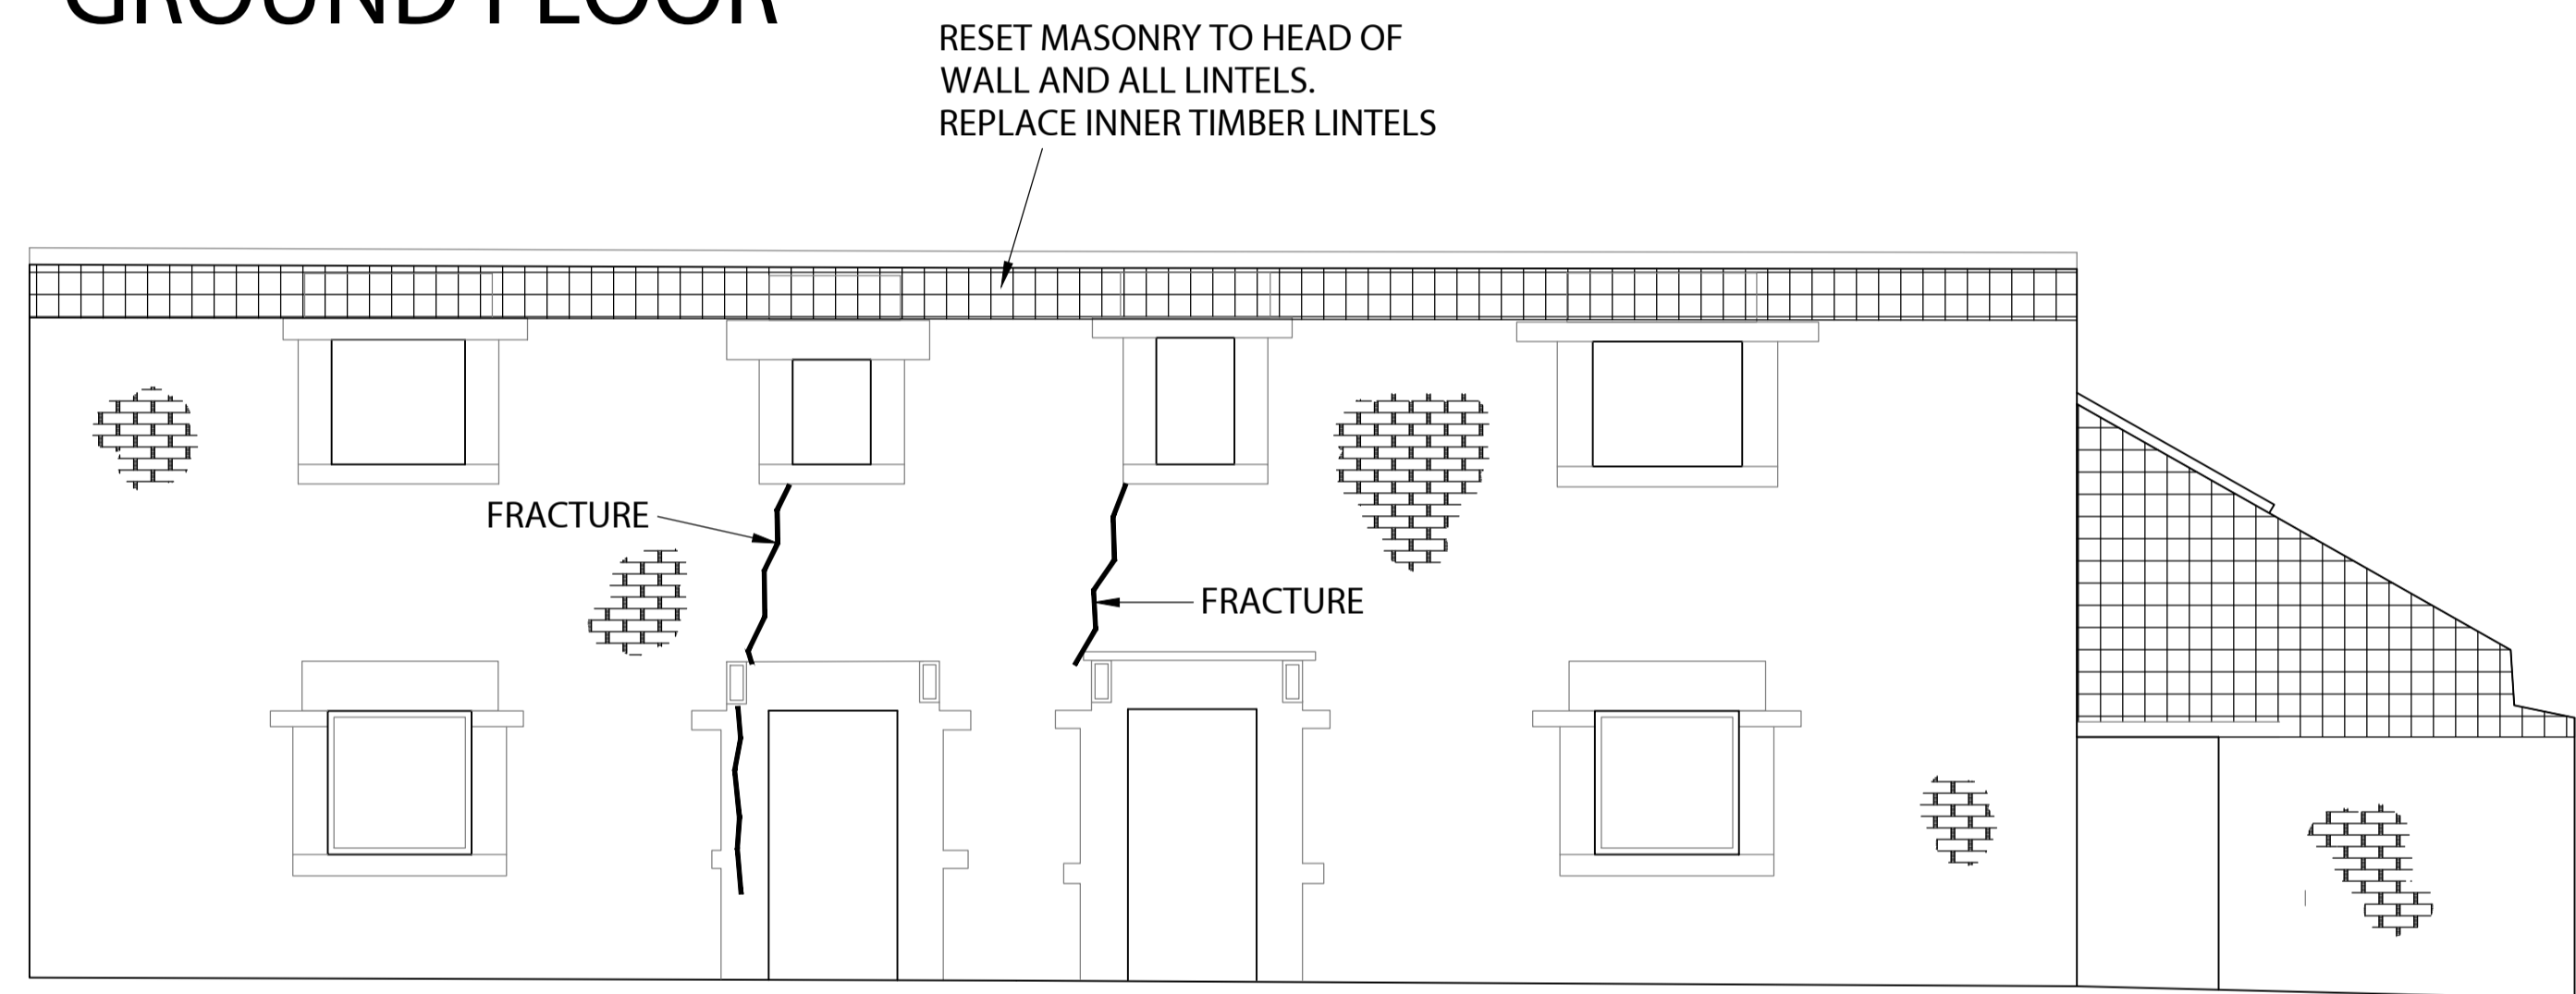
SOUTH ELEVATION

- 2.03 The areas of concern noted in October 2011 included:
- Loose masonry to the head of the front façade as well as fractures and damaged stonework to the same façade

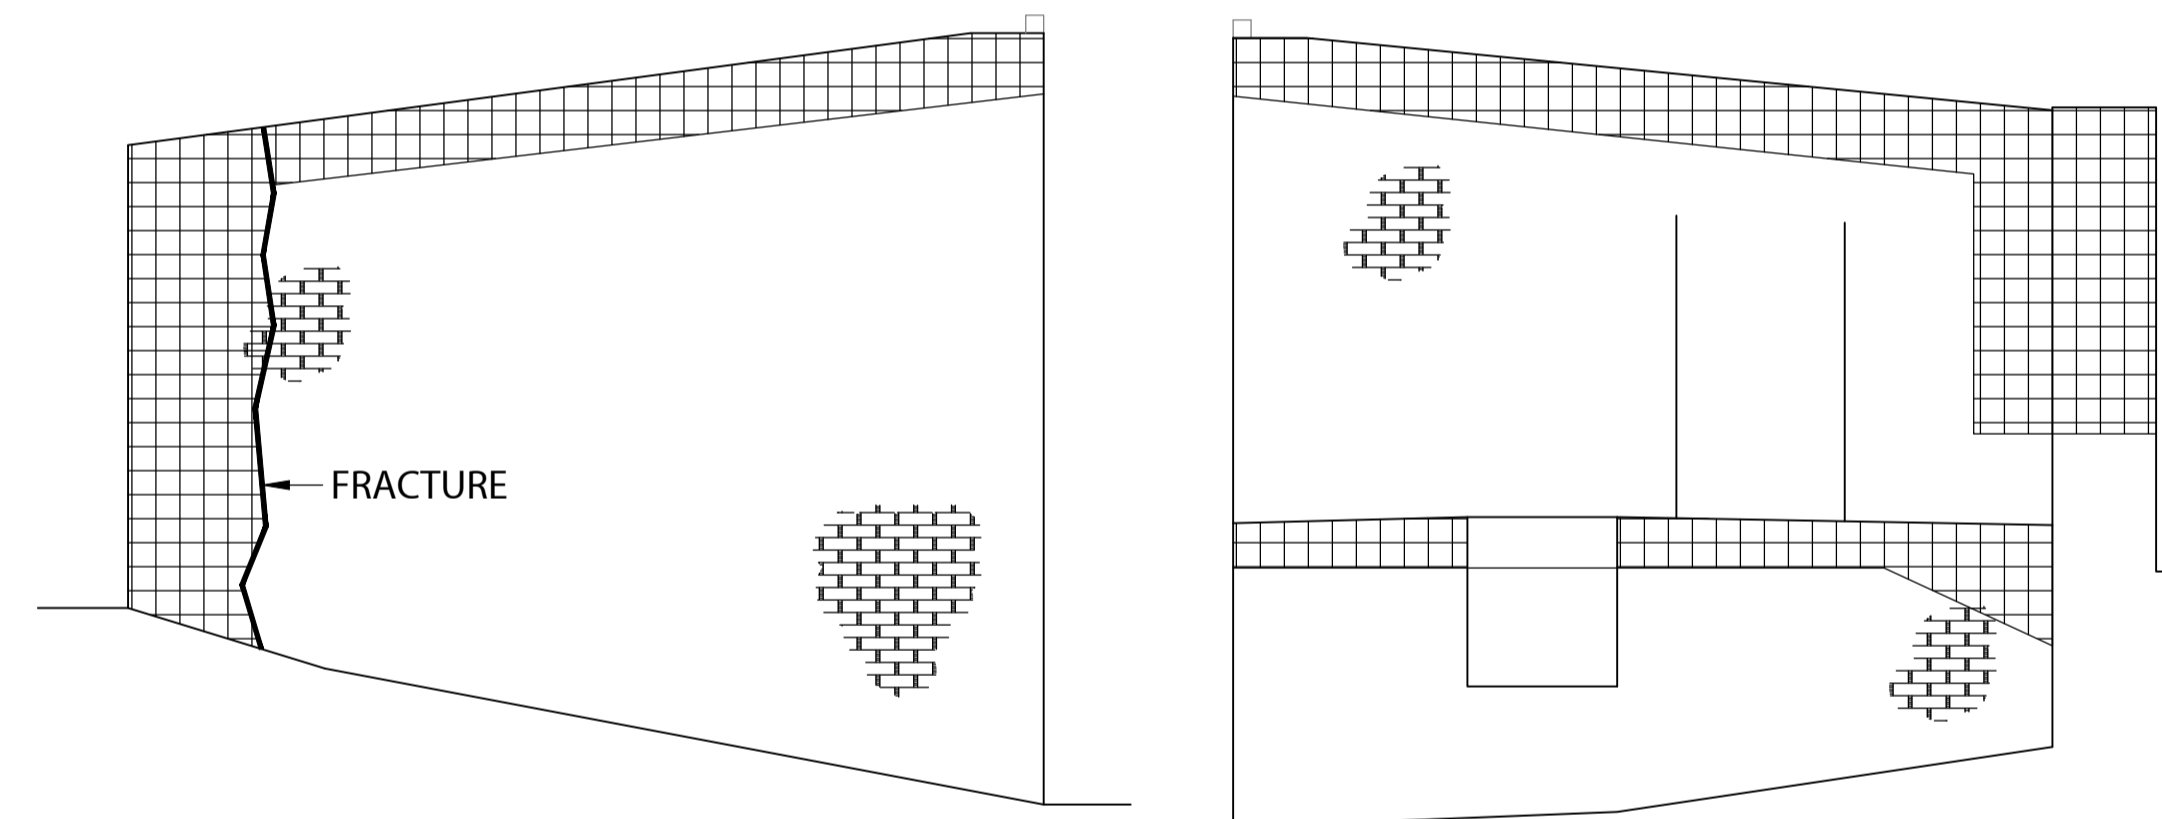
WEST ELEVATION

- Loose masonry to the head of the west elevation and in the section of wall north of the vertical fracture
  - Loose masonry to the head of the east wall as well as the junction with the north wall

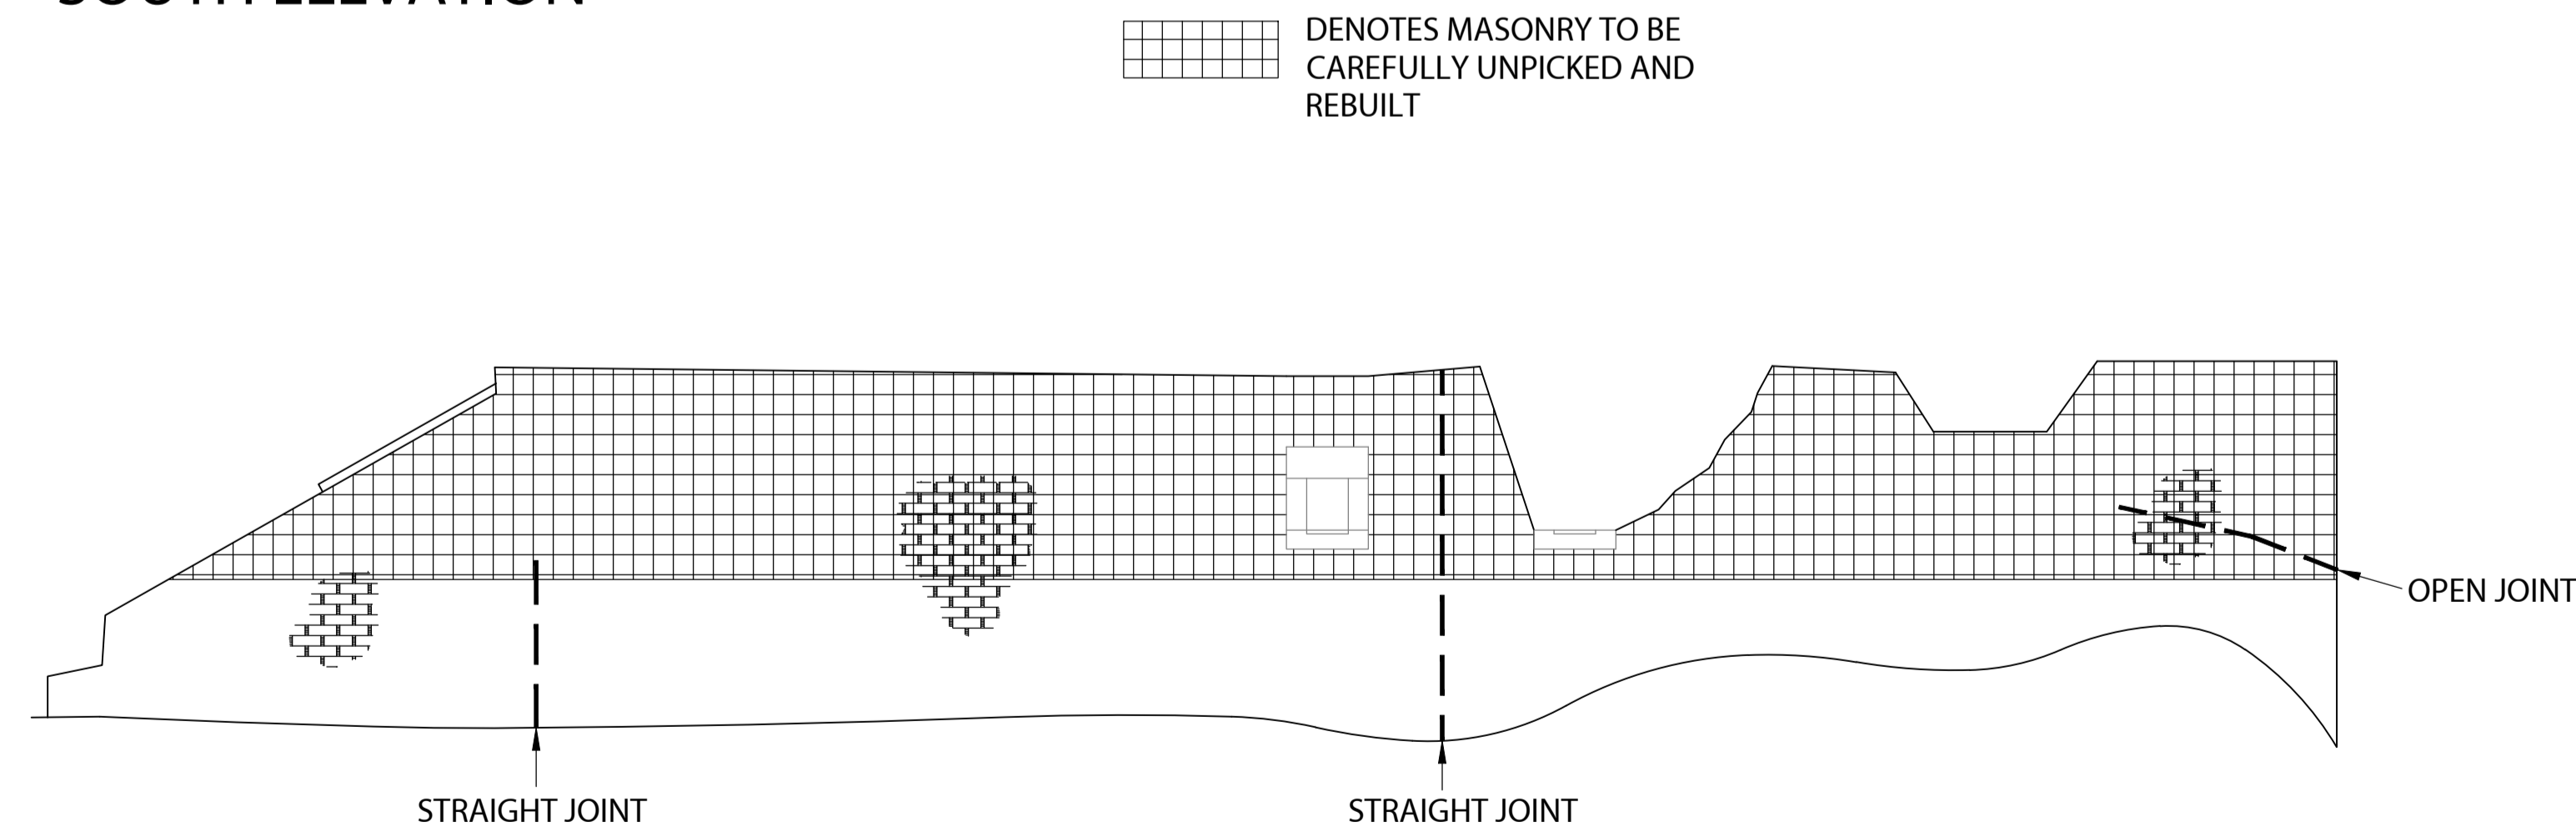
NORTH ELEVATION

- Poor masonry condition to the whole upper portion of the north wall.
  - The report notes the presence of a lot of vegetation growing over and out of the masonry particularly on the east and north elevations.
