Charmydown Barn St Catherine Bath & NE Somerset  
Supplementary Heritage Statement.

February 2022

# Charmydown Barn, St Catherine Bath & NE Somerset. Supplementary Heritage Statement.

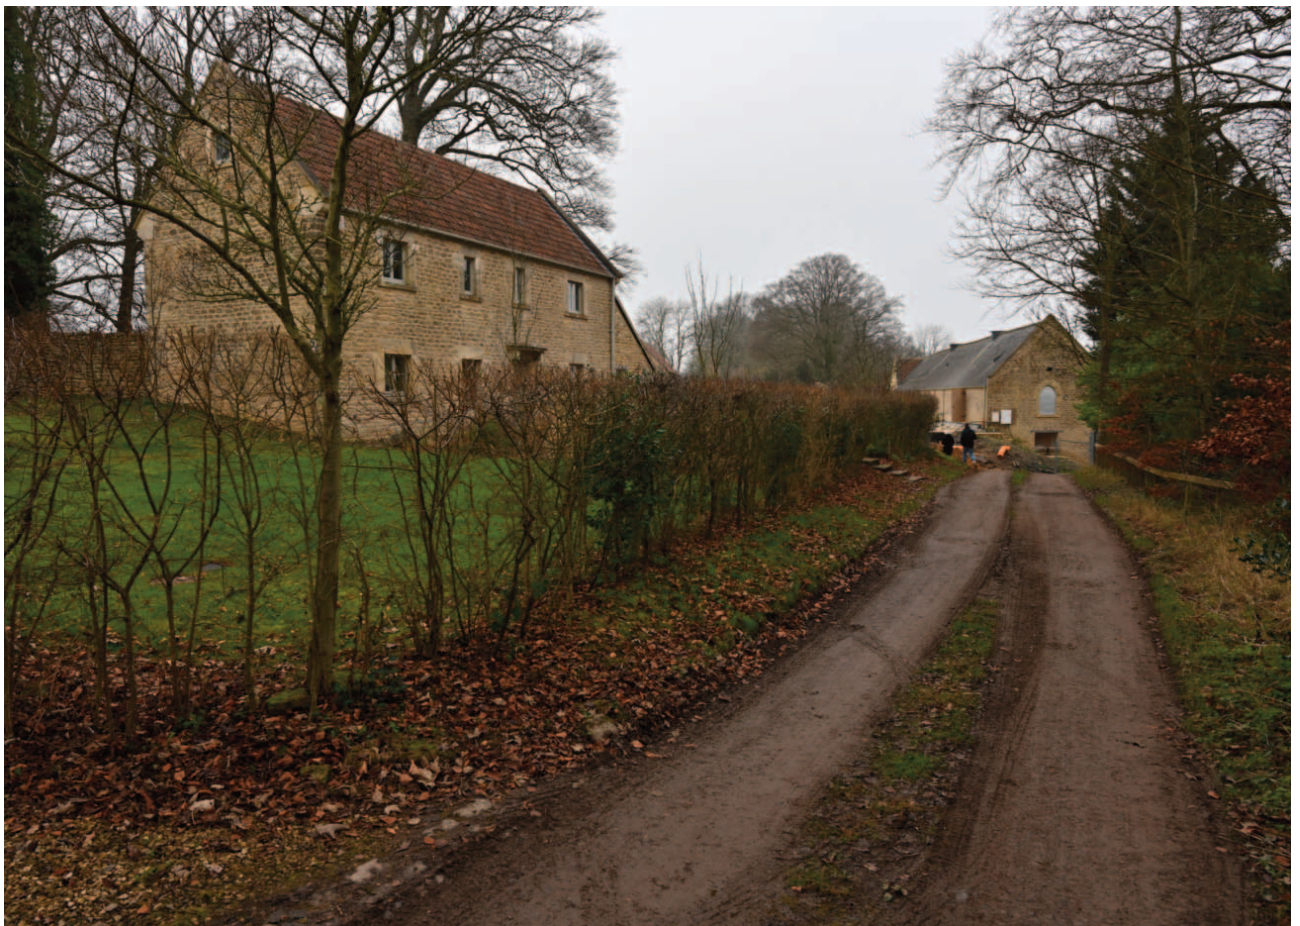
Fig 1. The barns seen from the modern upper access track with the converted cottages on the left and on the right the 19th century belt of trees screening the farmyard from the farmhouse.

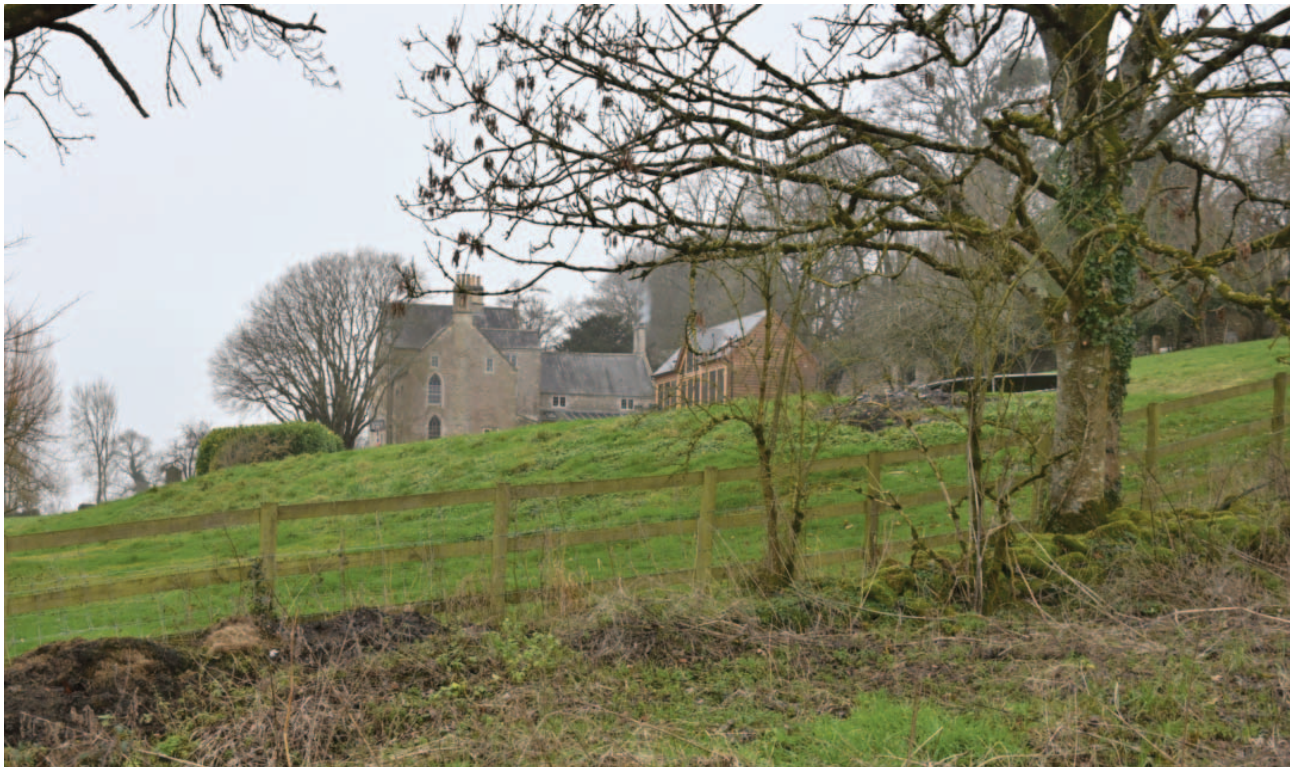
Fig 2. The listed farmhouse seen from the footpath running down the hillside below the farmyard. The belt of woodland on the right screens the house from the farmyard which is out of view to the right.

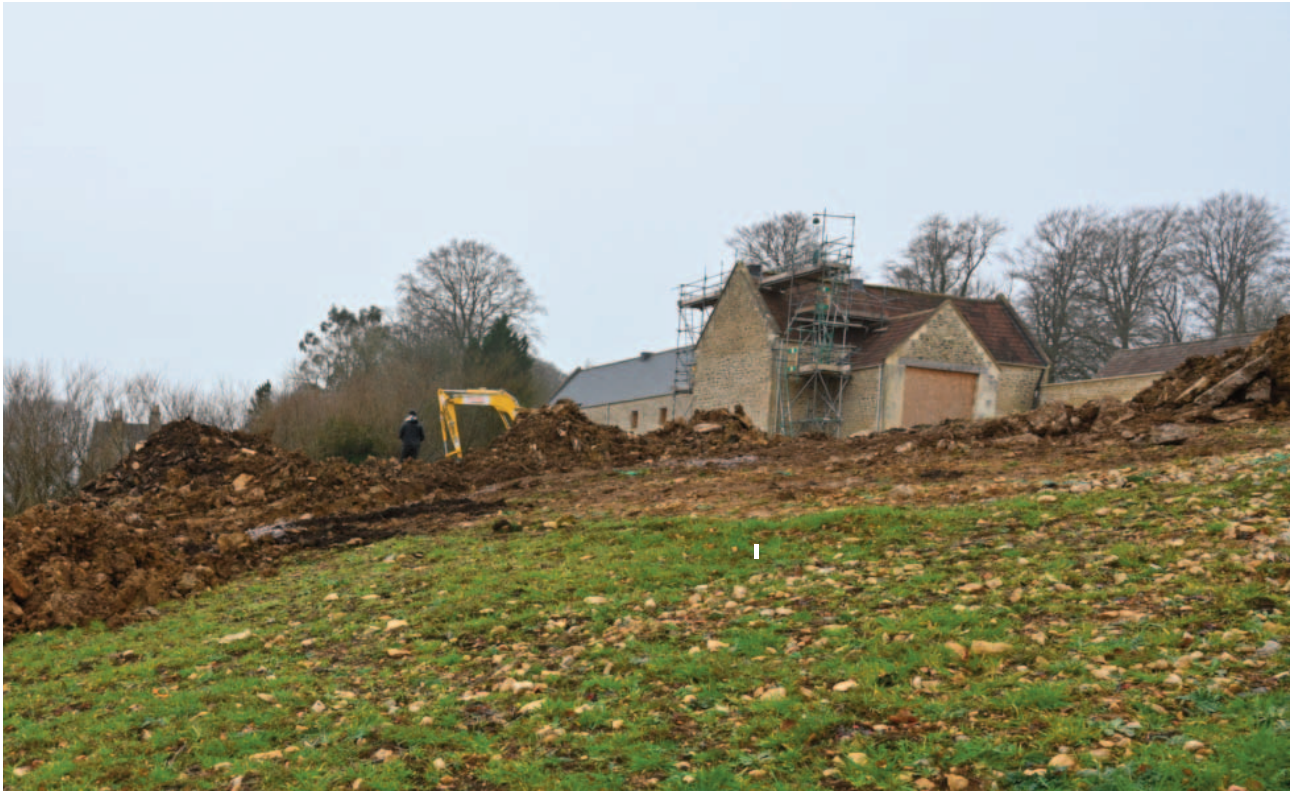
Fig 3. Only in oblique views from the south and southwest are the farmhouse and barns visible together, but separated by the 19th century belt of planting along the north side of the original west access.

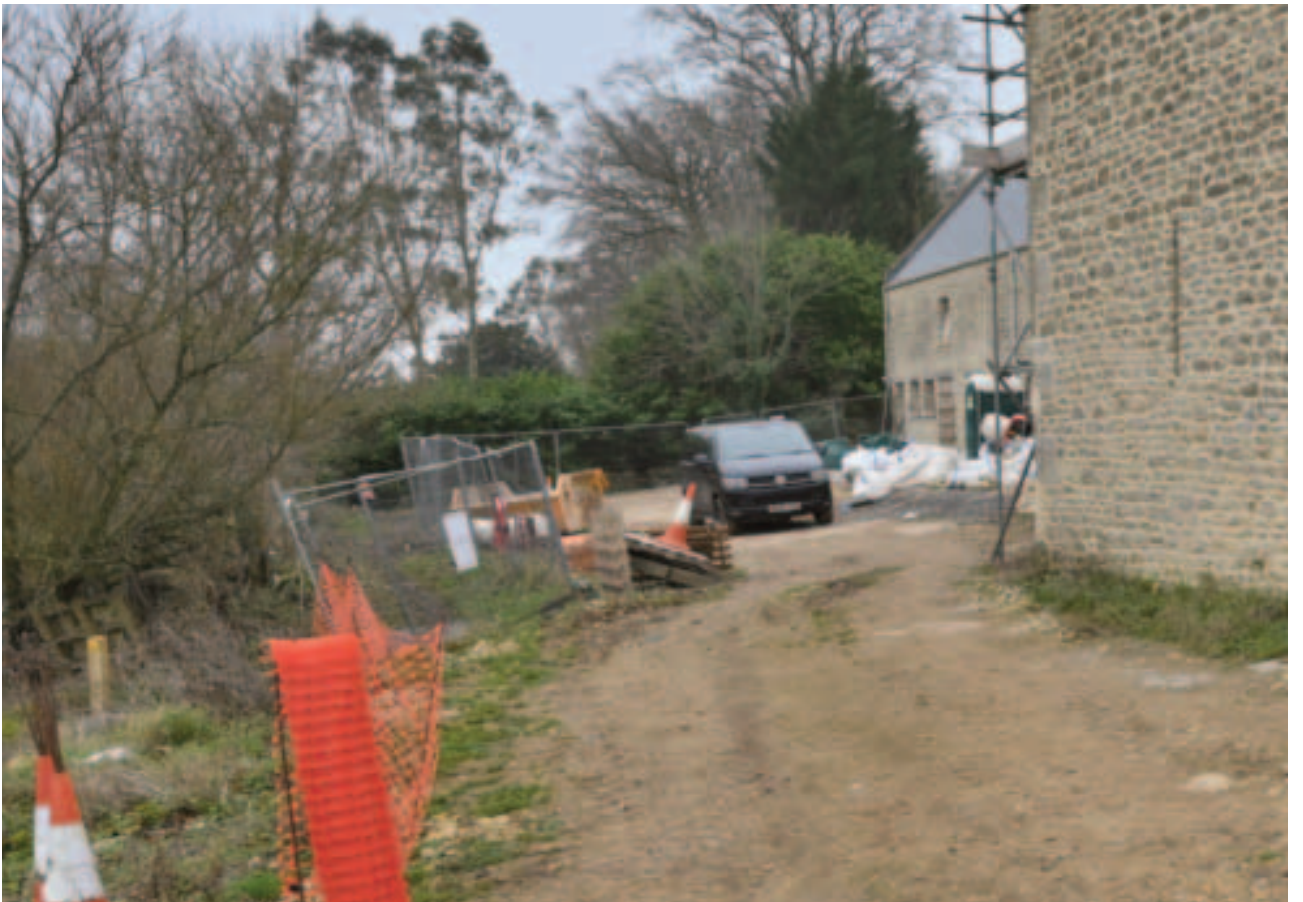
Fig 4. The 19th century west access lane emerged into the farmyard to the left of the grey van, with the belt of 19th century planting on the right. A chimney of the farmhouse is distantly just visible beyond the hedge.

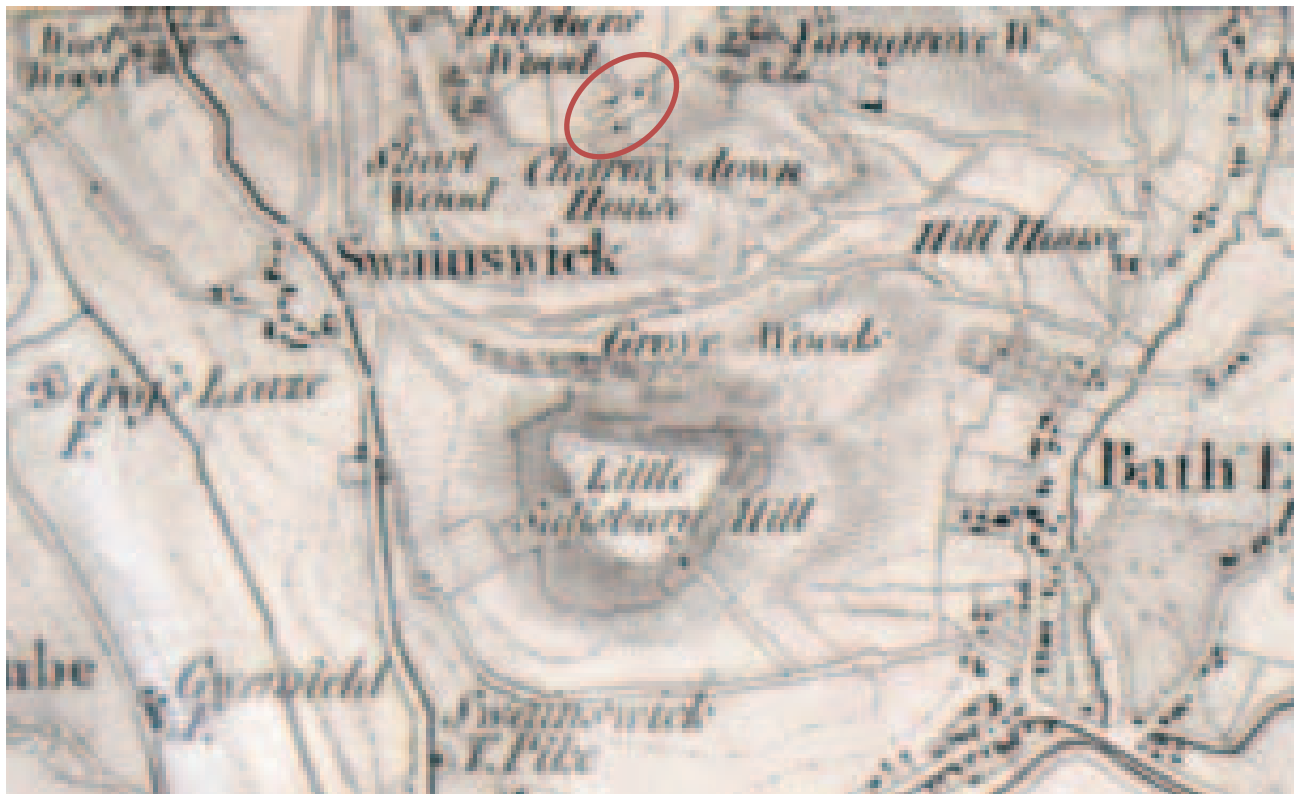
Fig 5. The 1817 one inch Ordnance Survey map shows the farmhouse with the farm cottages and barn to the north on either side of the access track running northwards to Charmy Down.

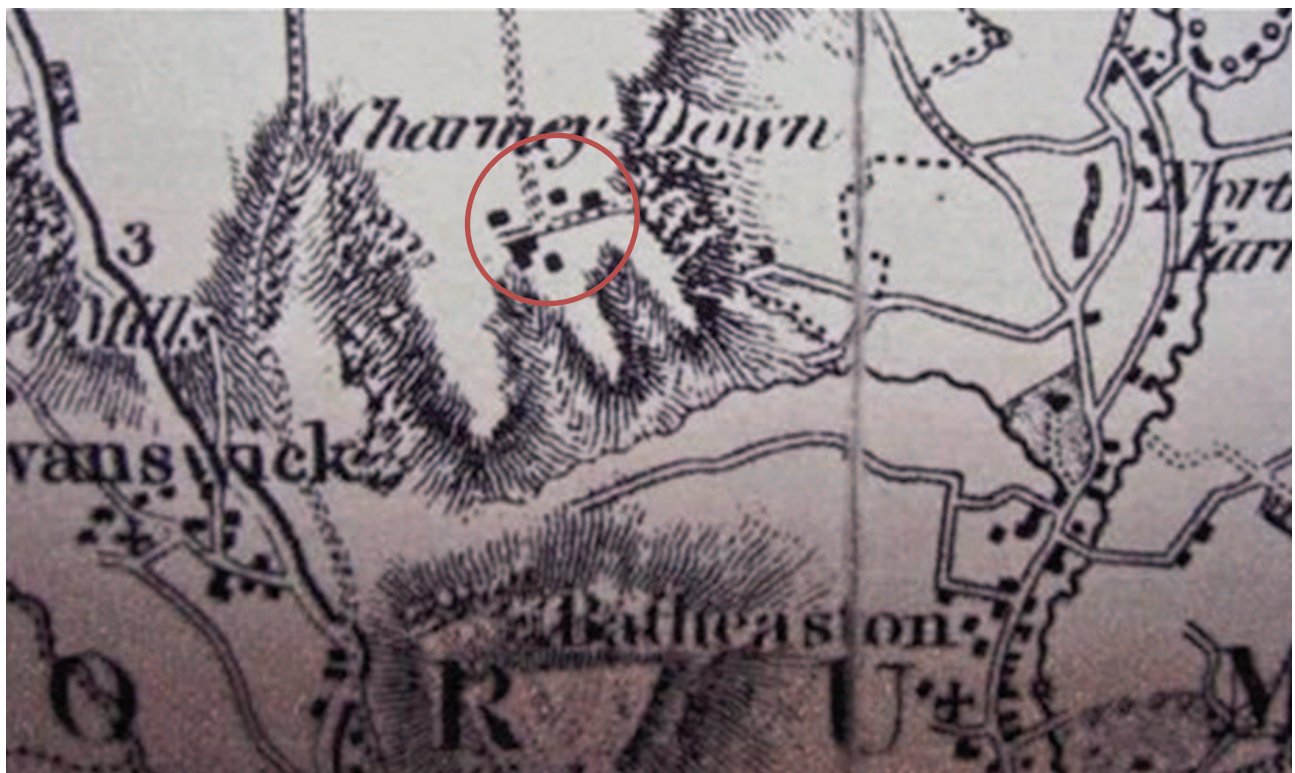
Fig 6. The 1822 Greenwood map shows the site more clearly with the access track separating the farmhouse from the farm buildings and cottage.

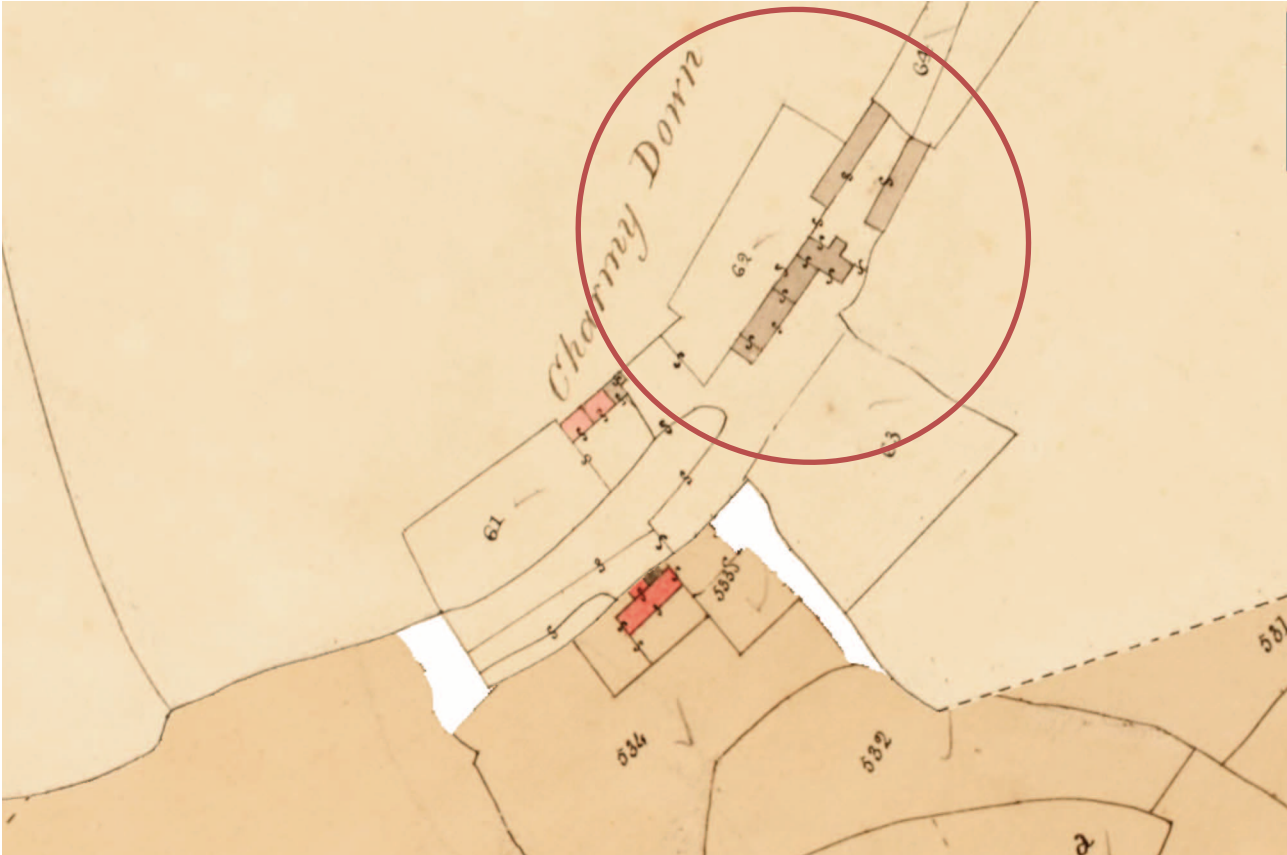
Fig.7. The 1840 tithe maps show the farmhouse separated by a series of enclosures from the farm cottages and barns. The same enclosures are shown in more detail on the 1883 OS map below.

This tithe map clearly shows the farm, with the farm cottages separately enclosed to the north and west of the farmyard whilst the barn and pigsties (or more probably open fronted animal shelters) lie to the northeast. The farmhouse and stables are separated by a series of enclosures from both the farmyard and farm cottages. The same enclosures appear on the more detailed 1883 1st edition

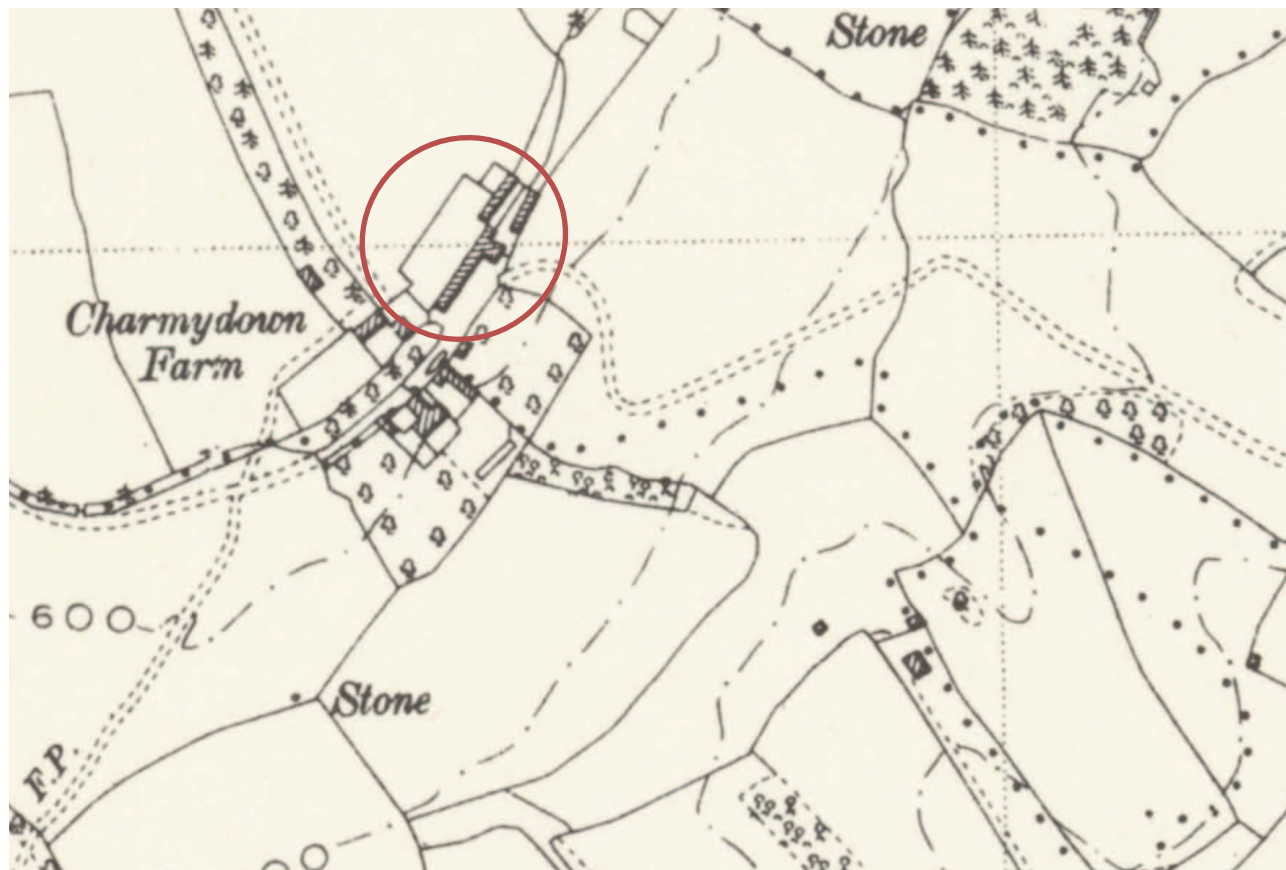
Fig.9. The 1936 survey ordnance survey map shows the same arrangement survived into the mid-20th century . The gated west access track is clearly shown as is the original lane running to the north and south of the farmyard.

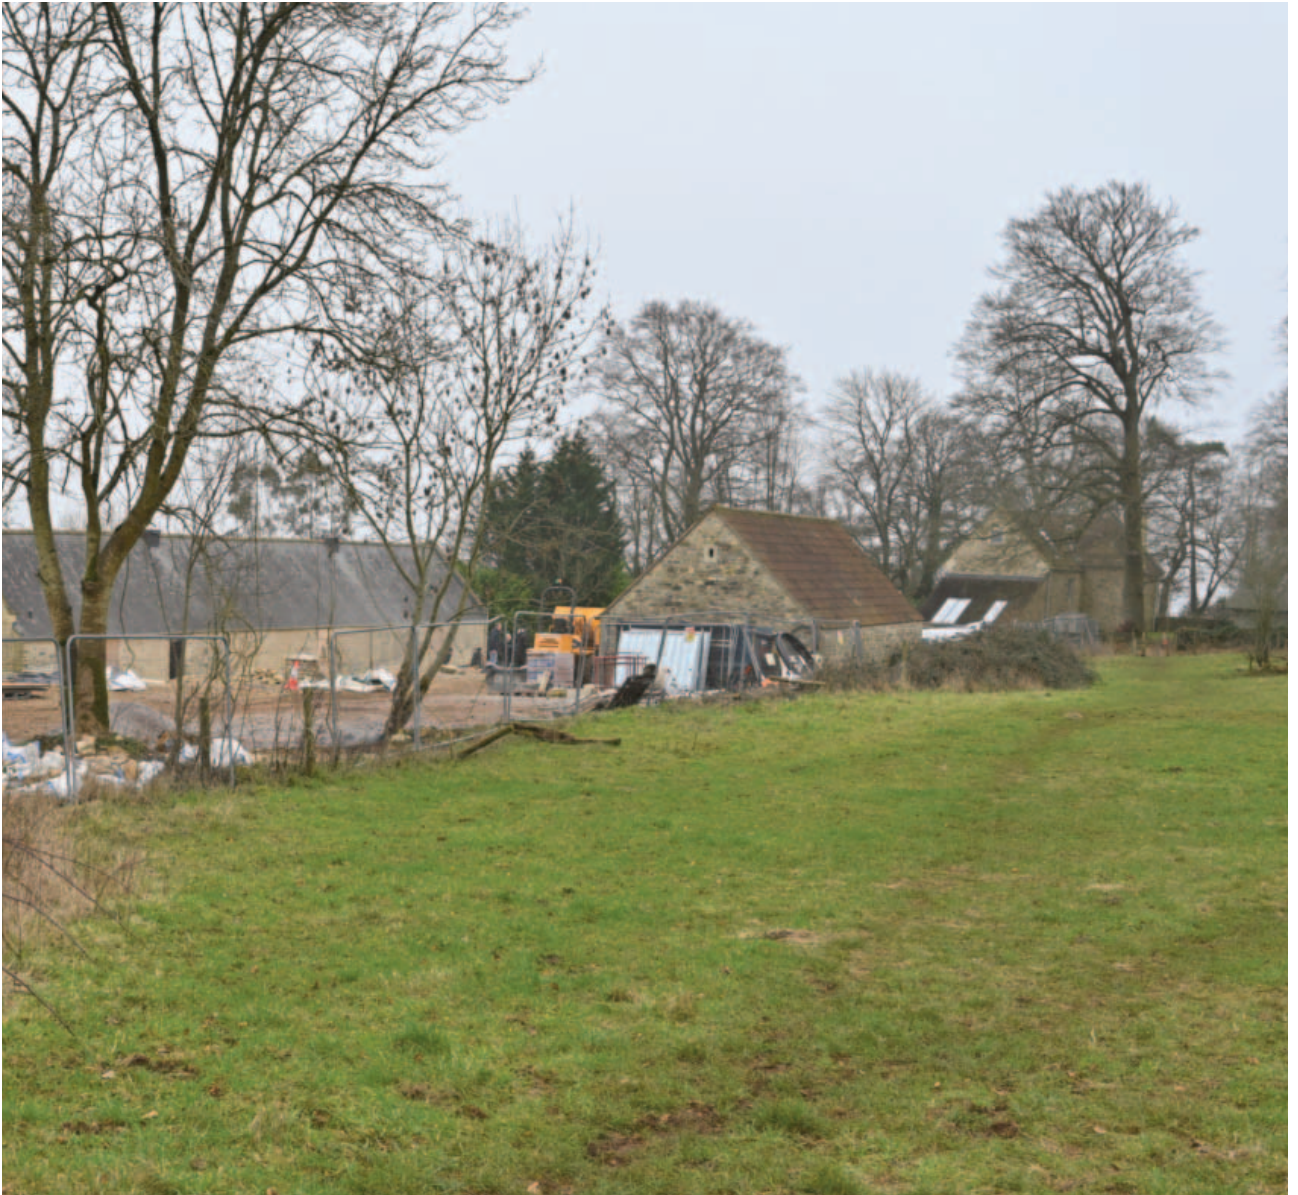
Fig. 10. In contrast to the farmhouse, the former farm cottages on the right are clearly visible from the farmyard and relate closely to it.

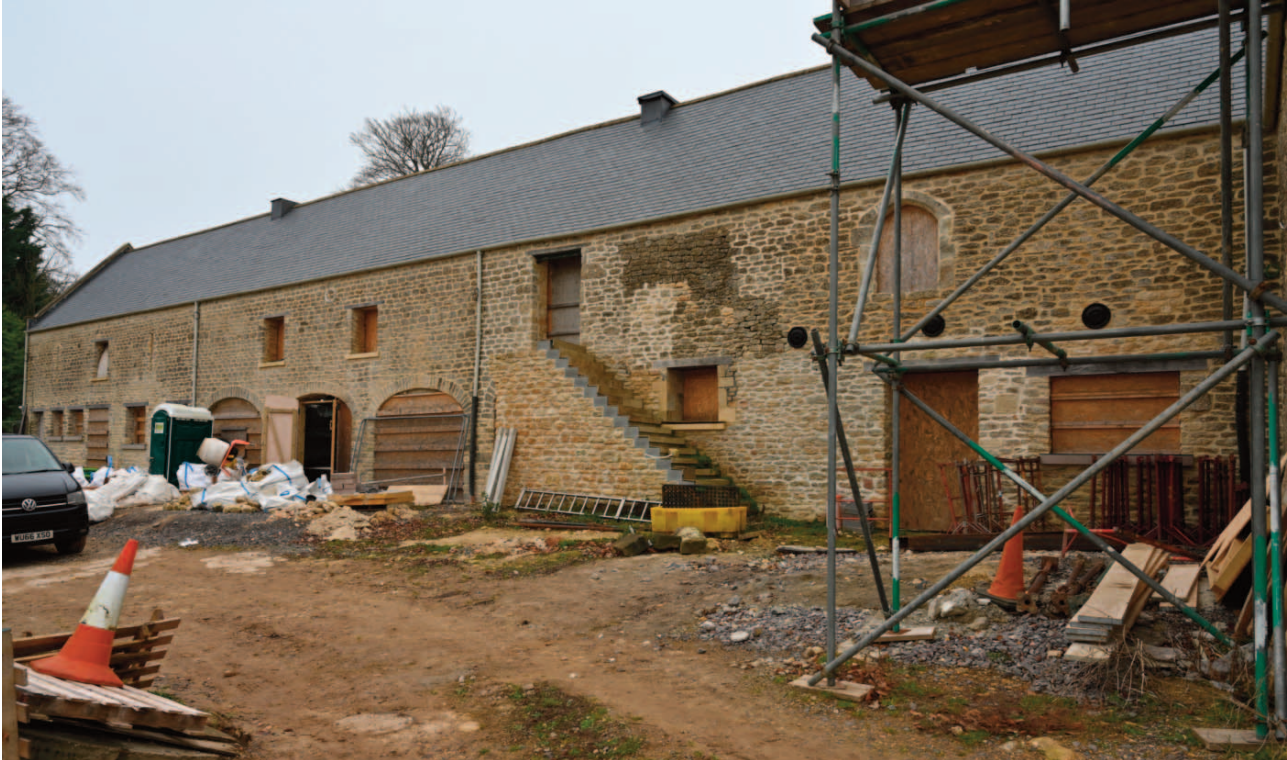
Fig. 11. The southeast elevation of the main barn, comprising the older central section with its reused arched first floor opening, and to the left of the taller steps an extension with four arched ground floor openings and a further extension to the left. The attached full height cross barn is just out of sight on the right.

The main historic early 19th century barn is described in detail in the Heritage Statement and comprises a long two storey range with a single-volume barn set at right angles at its northeast end. The central section is the earliest and is understood to date from c.1802 with the northeast cross barn being added in the 1820's, together with a contemporary extension range to the southwest side of the 1802 range, detailed with a series of four arched door openings. A further small extension to the west end side had been added by 1840. Seen from the south, the front elevation of this long range appears to be of two storeys but because of the sloping ground it appears as a single storey range from the north.

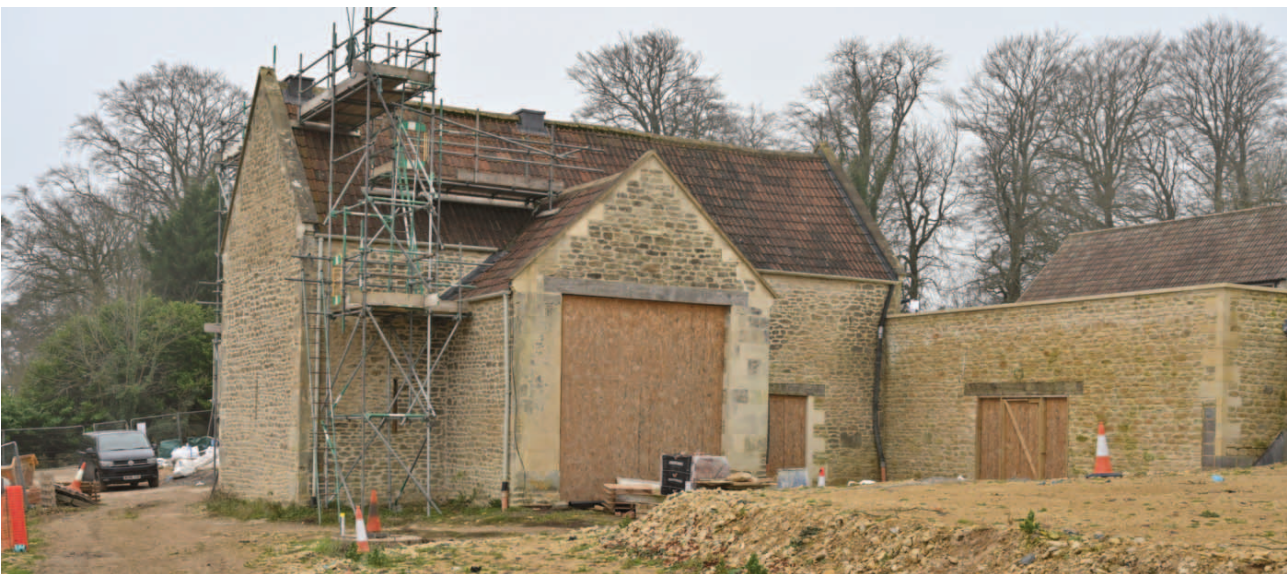
Fig. 12. The full height northeast cross barn with its off-centre midstorey and on the right the rebuilt retaining wall to the upper farmyard. The levelled material in the foreground is to be removed.

At the northeast end of the two storey range is an attached full height cross barn that breaks forward in front of the southeast elevation. Its northeast elevation detailed with an off-centre midstrey, that breaks forward in front of the elevation. Beyond this substantial farm building was a third yard which was partially terraced and separated from the higher level yard to the rear by a tall stone retaining wall. This eastern yard contained two open fronted ranges facing towards each other, both of which were derelict and roofless in 2012. The north range built against the tall stone retaining wall to the upper yard retained the remains of circular stone columns which would have supported the roof. The rebuilding of this outbuilding formed part of the 2012 scheme.

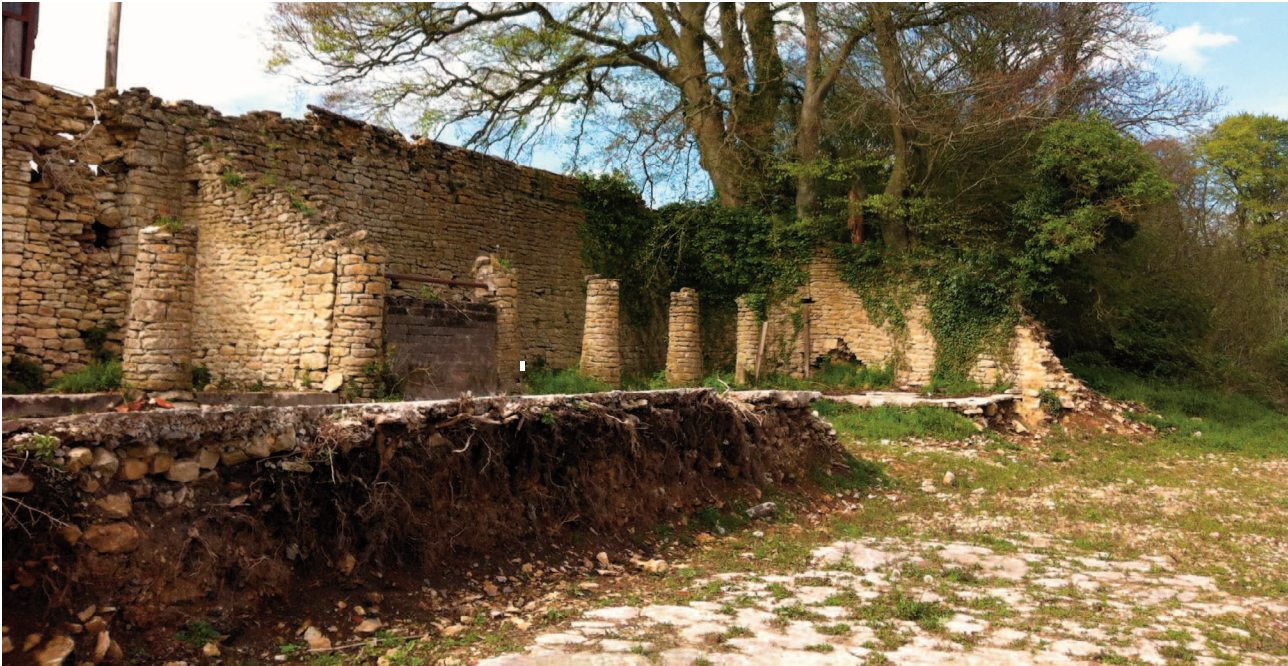
Fig 13. The former open fronted building in 2008 showing its derelict condition prior to rebuilding.

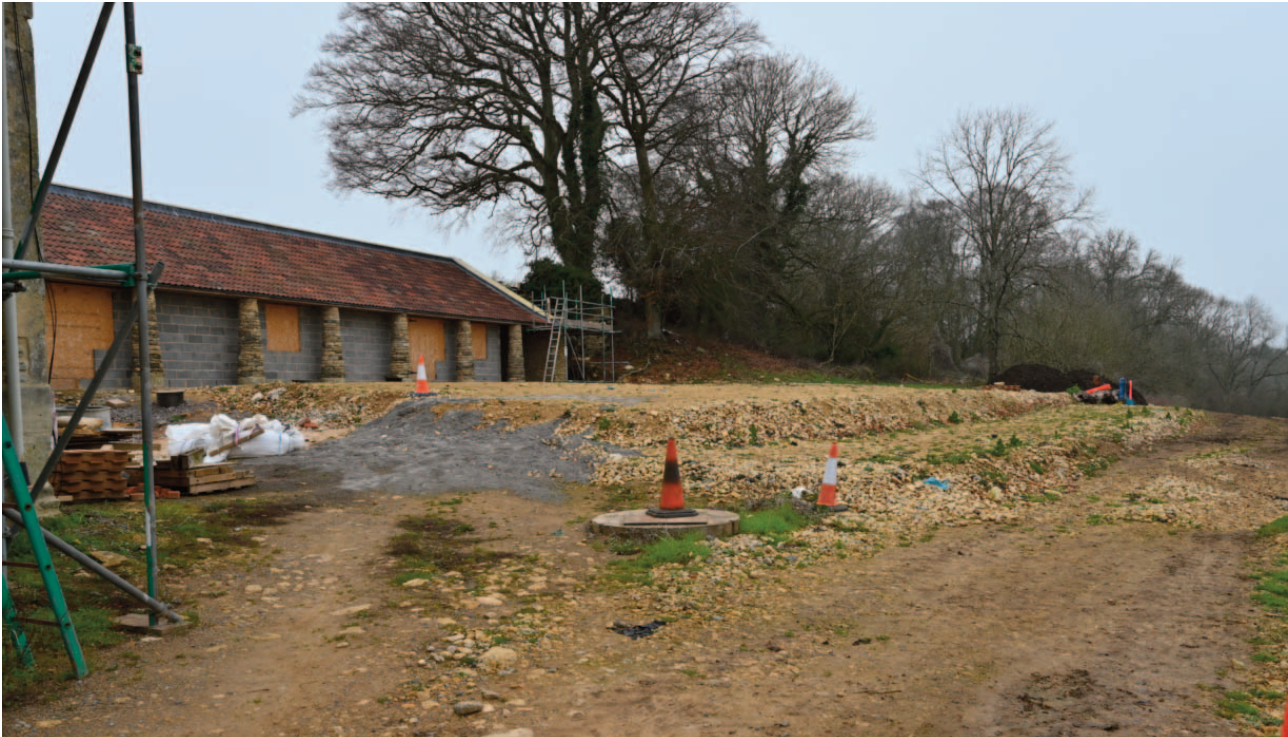
Fig. 14. The restored former open fronted outbuilding at the eastern end of the former farmyard.

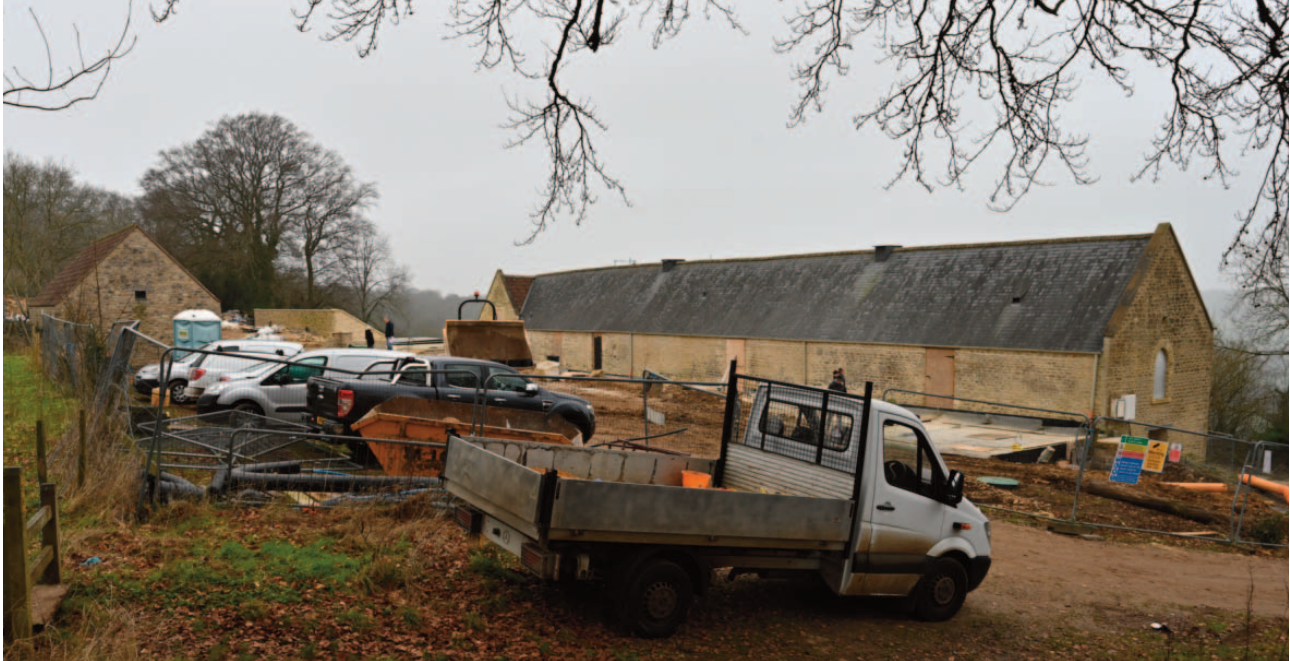
Fig. 15. The northwest elevation of the barn omitting the three approved rooflights. The electricity supply boxes on the west gable are temporary

The exposed section of the rear elevation of the historic barn is as approved in 2012 with the exception of the omission of three approved rooflights. The flues were approved under a separate application for discharge of conditions in 2014.

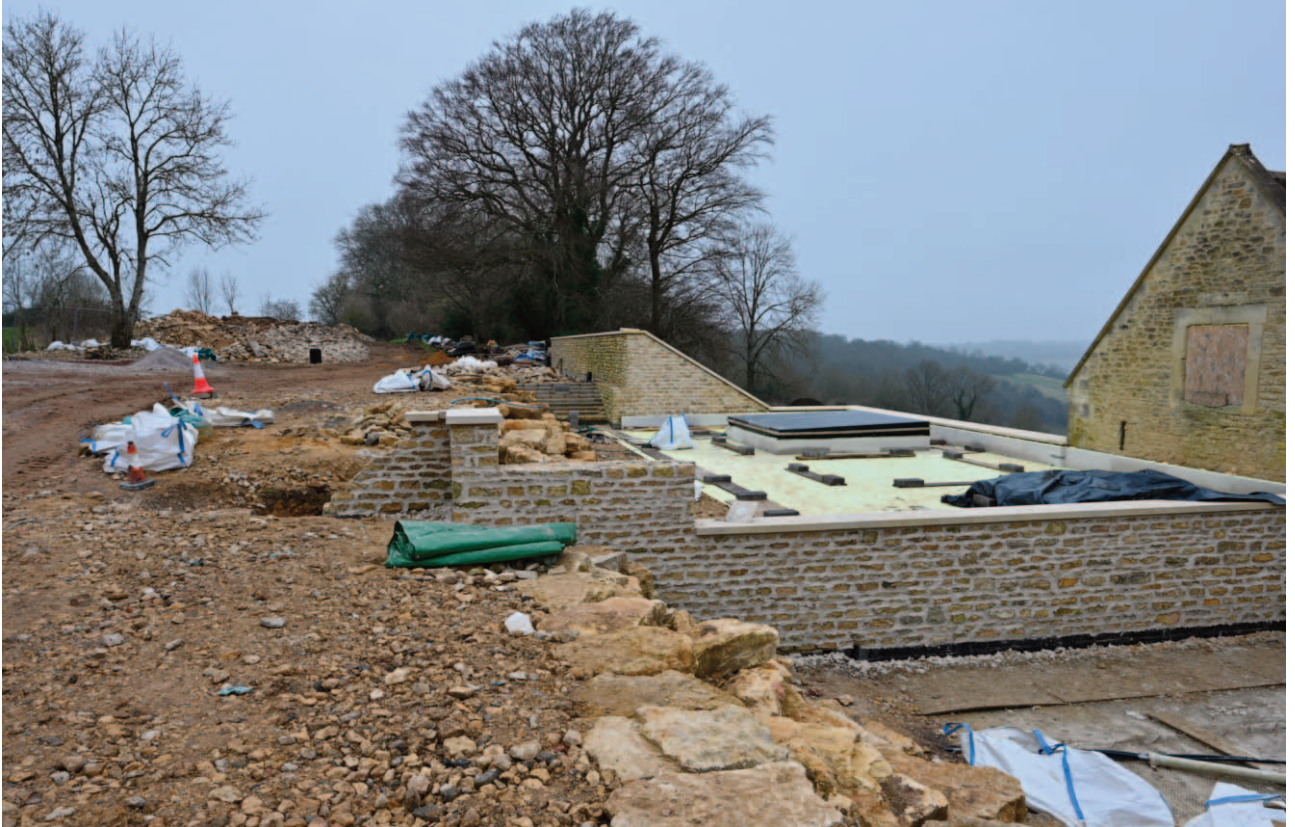
Fig. 16. The previously approved flat roofed rear extension with two rooflights rather than one, and omission of the parapet wall between the barn and outbuilding. It is proposed to install a low glass screen for safety in order to reduce the impact of the wall on the barn and former piggery range.

To the rear of the main barn and extending beyond it to the north behind the retaining wall to the upper yard was the flat roofed extension approved in 2012. The approved detail was for this slightly raised flat roof to be finished with gently sloping landscaping finished with a rubblestone parapet detailed as a stone wall linking the eave of the cross barn to the rebuilt former piggery (see landscaping description below). The 2012 approval had a single pyramidal rooflight set into this roof. As constructed this has been repositioned and two small walk-on rooflights have been introduced and the parapet wall has been lowered. For safety it is proposed to install a non-reflective glass balustrade in place of the parapet wall

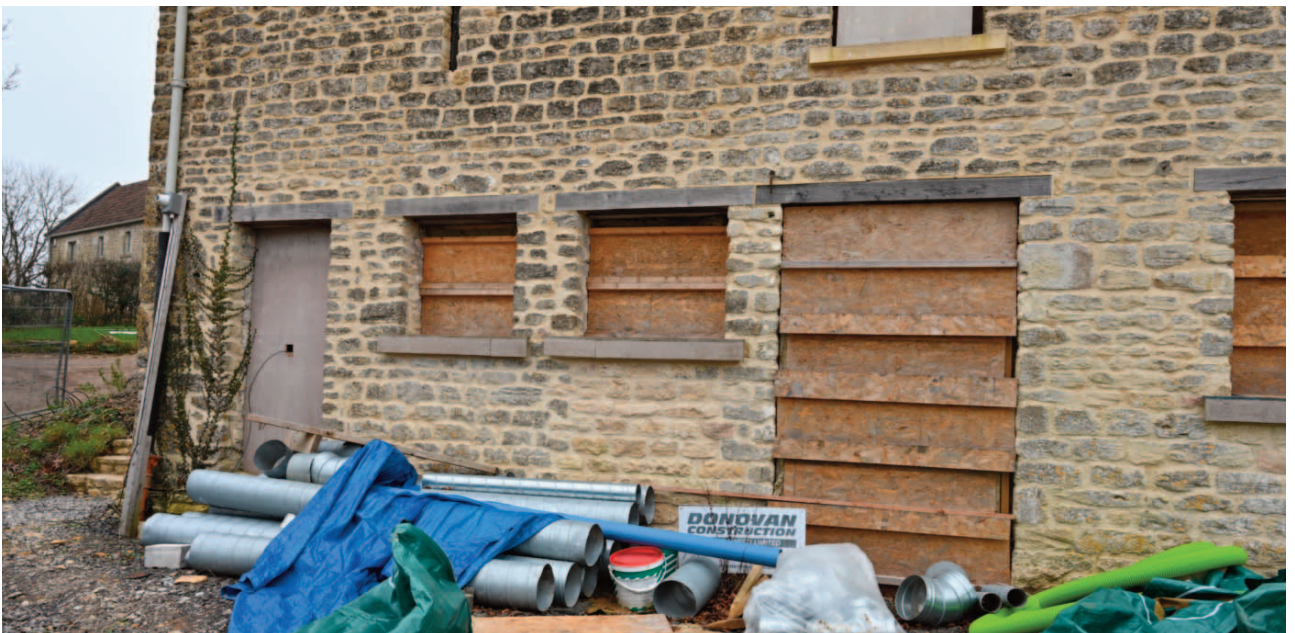
Fig. 17. The right hand window just visible here has been retained rather than replaced by a second door as approved.

The only changes to this elevation are to two small openings at the southwest end at ground floor level. A new door approved in 2012 has been retained as a window whilst the adjacent window in a blocked doorway has been deepened slightly. These changes retain more historic fabric. In all other respects this elevation is as-approved.

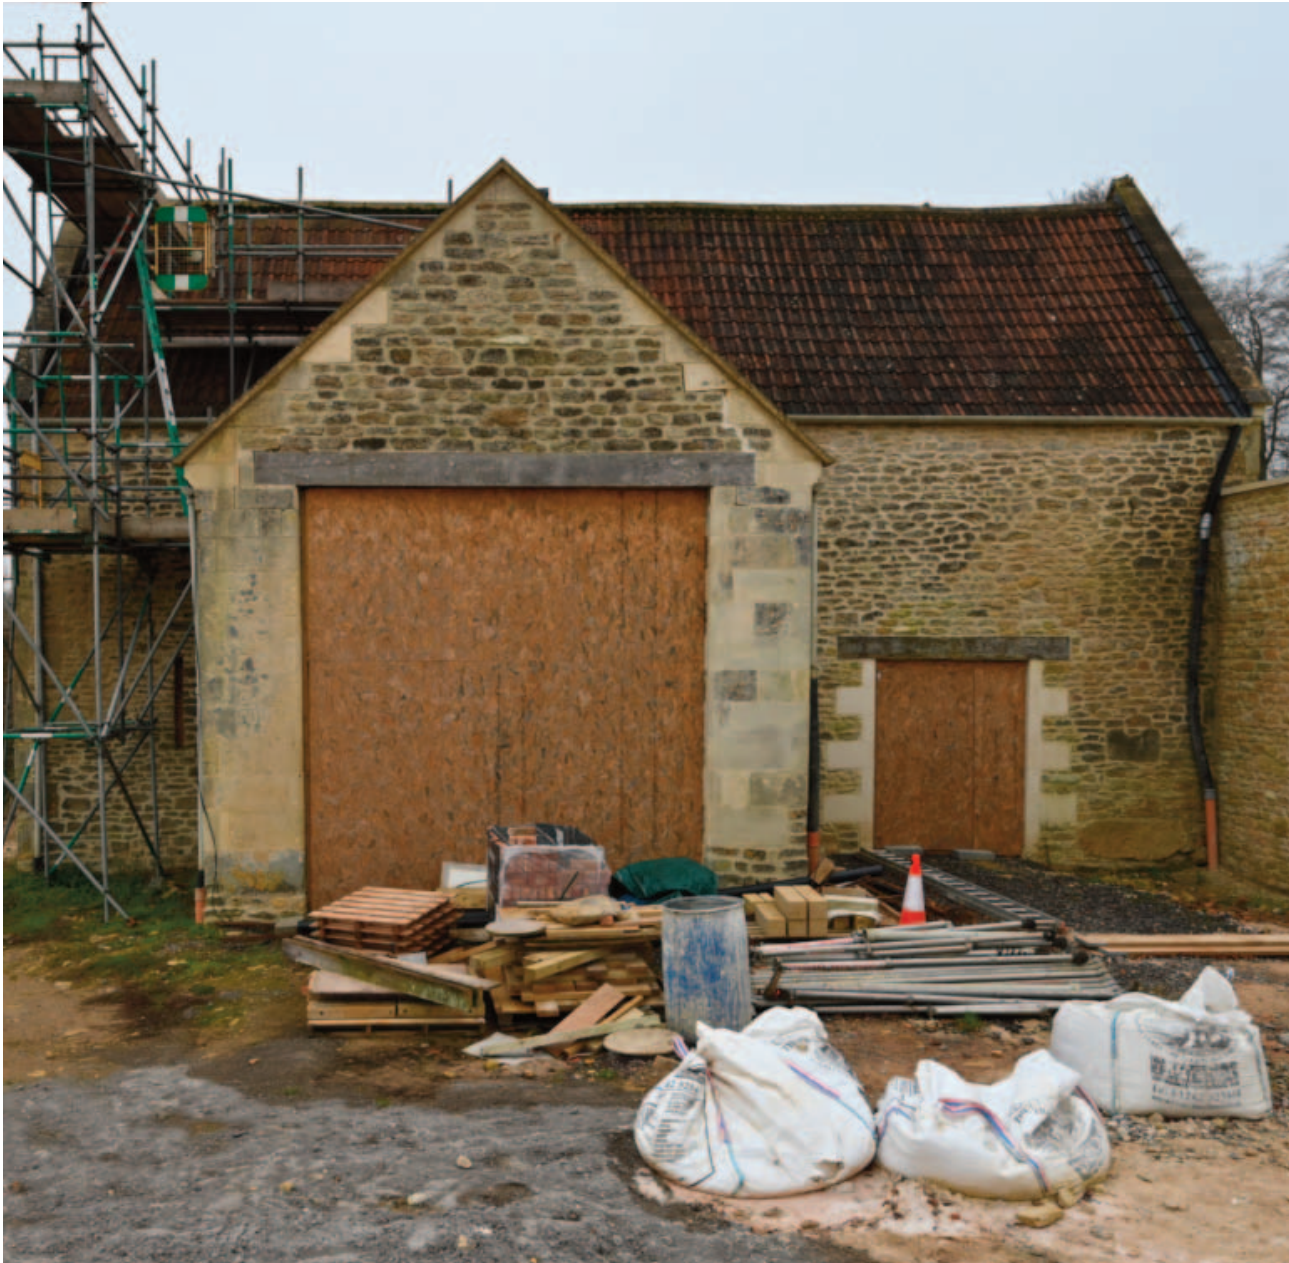
Fig. 18. The northeast elevation of the barn with the inserted opening replacing a former ventilation slot.

A new flue is proposed on the roof to this barn. A new door opening has been formed to the right (north) side of the midstrey incorporating a pair of French doors. This has been detailed with an exposed oak lintol and dressed stone quoining to the sides and has replaced a single arrow slit ventilation slot. Historically, the ground level rose along this side of the barn, with the adjacent retaining wall to the right being partially underground, and this levelling formed part of the 2012 approval.

This additional opening has caused harm to significance arising from the loss of historic fabric and the harm is increased by the introduction of quoining to each side of the opening. It is argued that similar quoining is found elsewhere on the barn and that as this part of the elevation is tucked into a corner behind the midstrey opening so is obscured from public view, the impact upon the character of this former farm building and its setting has been minimised.

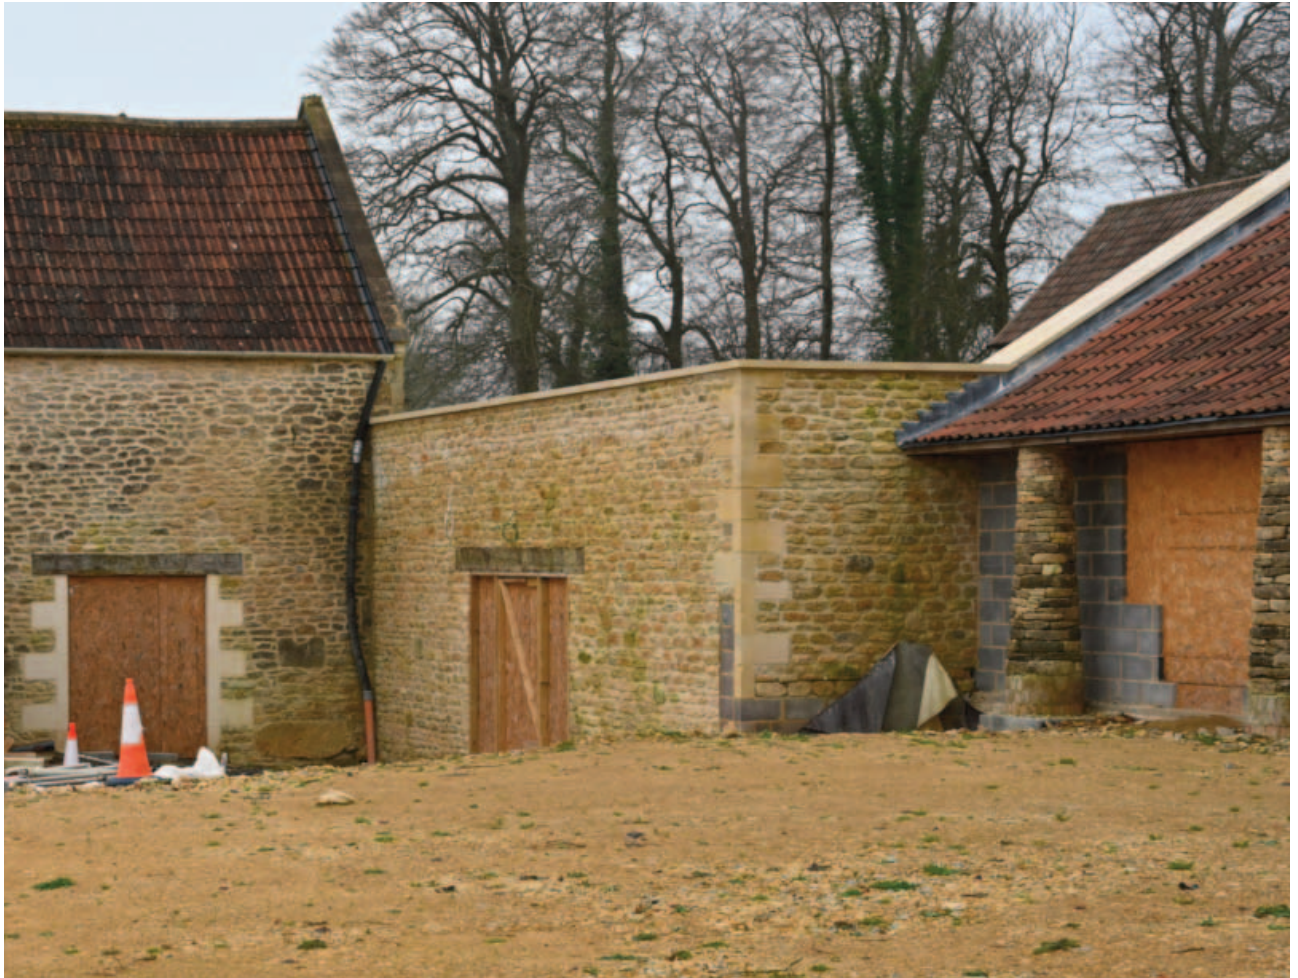
Fig. 19. The rebuilt front wall to the flat roofed extension between the main barn and the former pigsty building. The angle has been changed slightly and the wall is to have non-reflective glass parapet

This former retaining wall forms the southeast and northeast elevations of the approved 2012 flat-roofed extension. As approved it was to retain a historic slight change in alignment along the front of the new flat roofed extension behind. It has been rebuilt as a right-angled wall between the barn and former pigsty and it has been terminated at flat roof level instead of rising to eave level on the main barn in order to provide a low parapet to the flat roof behind.

As constructed the wall is finished 0.9m below the eave of the barn, and it is now proposed to finish the wall with a low glazed parapet using non-reflective glass, in order to reduce the visual impact that the taller wall would have upon the adjacent barn and former pigsty.

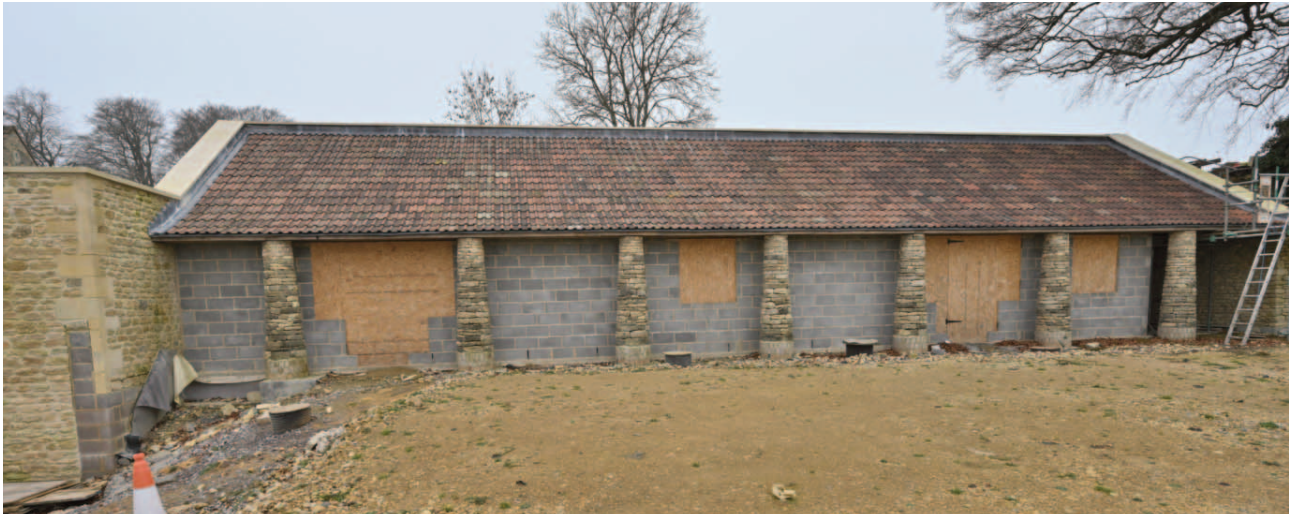
Fig. 20. The rebuilt former pig sty with its fully tiled roof and altered front wall. The omission of the glazed roof is regarded as a significant enhancement and if the render and fenestration is finished in recessive colours these alterations are considered to have an overall neutral impact on the character of the restored building.

As built the rear retaining wall has been completely rather than partly rebuilt to its original height and only the eight bays at the southwest end of the lean-to range have been reinstated. Of these only the east (right hand) end bay has been retained as an open store and the proposed glazed roof section has been omitted and the roof fully tiled. The seven remaining bays are to have a rendered front wall set back behind the carefully rebuilt stone piers and finished in recessive colours, incorporating two pairs of glazed French doors with slender windows to each side and two two-light case-ment windows.

The impact of the altered front elevation is reduced by being set back behind the carefully rebuilt stone piers and the introduction of a carefully detailed fully tiled roof is a significant enhancement over the previously approved glazed roof section.
