Charmydown Barn St Catherine Bath & NE Somerset  
Supplementary Heritage Statement.

February 2022

# Charmydown Barn, St Catherine Bath & NE Somerset. Supplementary Heritage Statement.

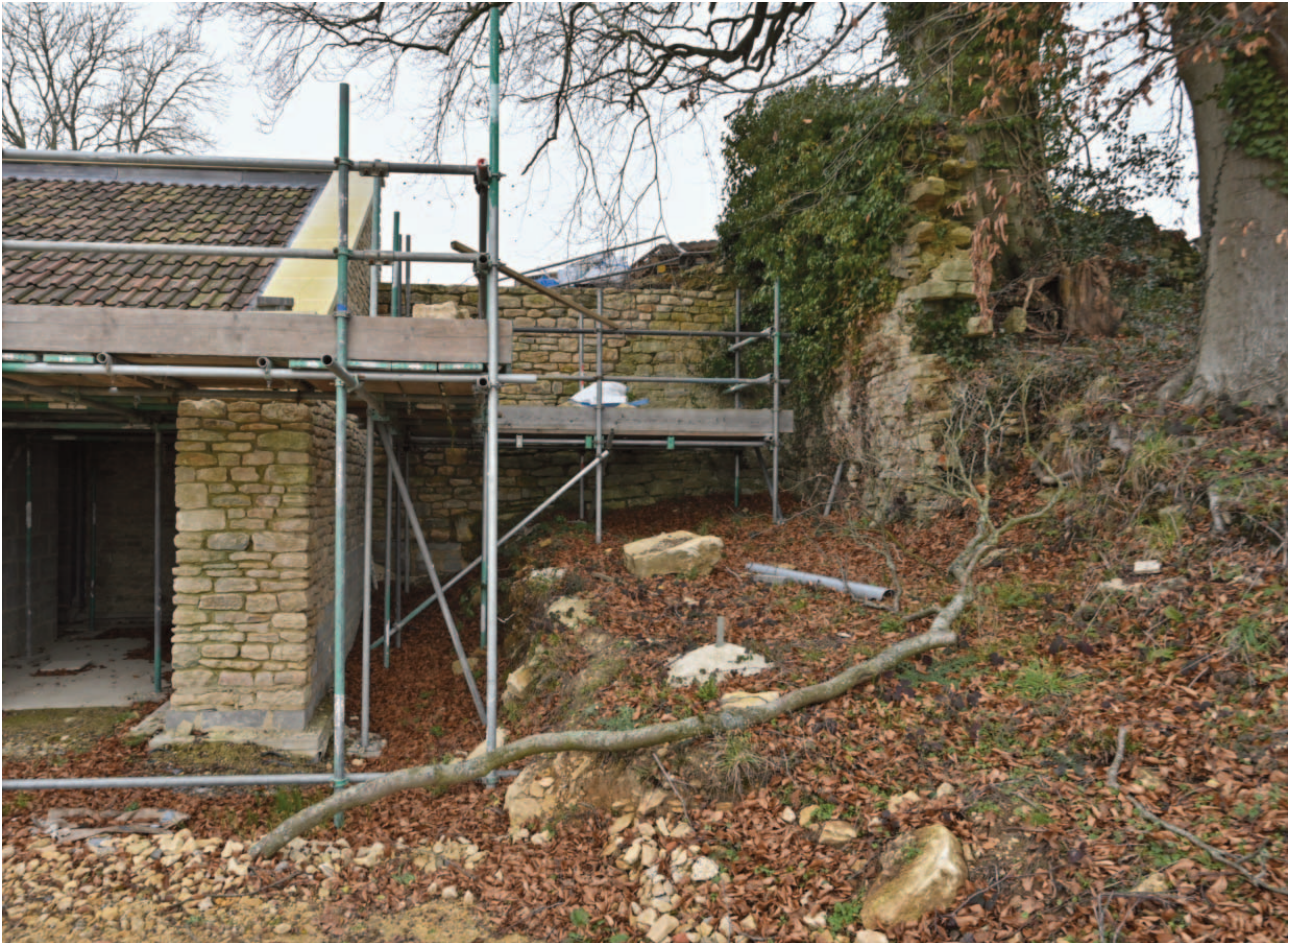
Fig. 21. The end bays of the former open fronted range have not been restored in order to protect the adjacent mature trees whose roots have encroached into the former gable wall.

Internally the building has been altered to provide a studio and study with associated en-suite facilities allowing the studio to be used flexibly for family and guests. At the northeast end the remaining bays have been left unrestored because it was felt that their restoration would compromise the immediately adjacent mature trees. It is proposed to restore the outer wall as a drystone boundary wall.

If the surviving sections of the rear and gable wall of the remaining collapsed end bays of this former open fronted farm building are carefully repaired together with the adjacent stone boundary wall, any harm arising from the failure to rebuild these end bays would be offset by the retention of the historic form of the rear and gable walls.

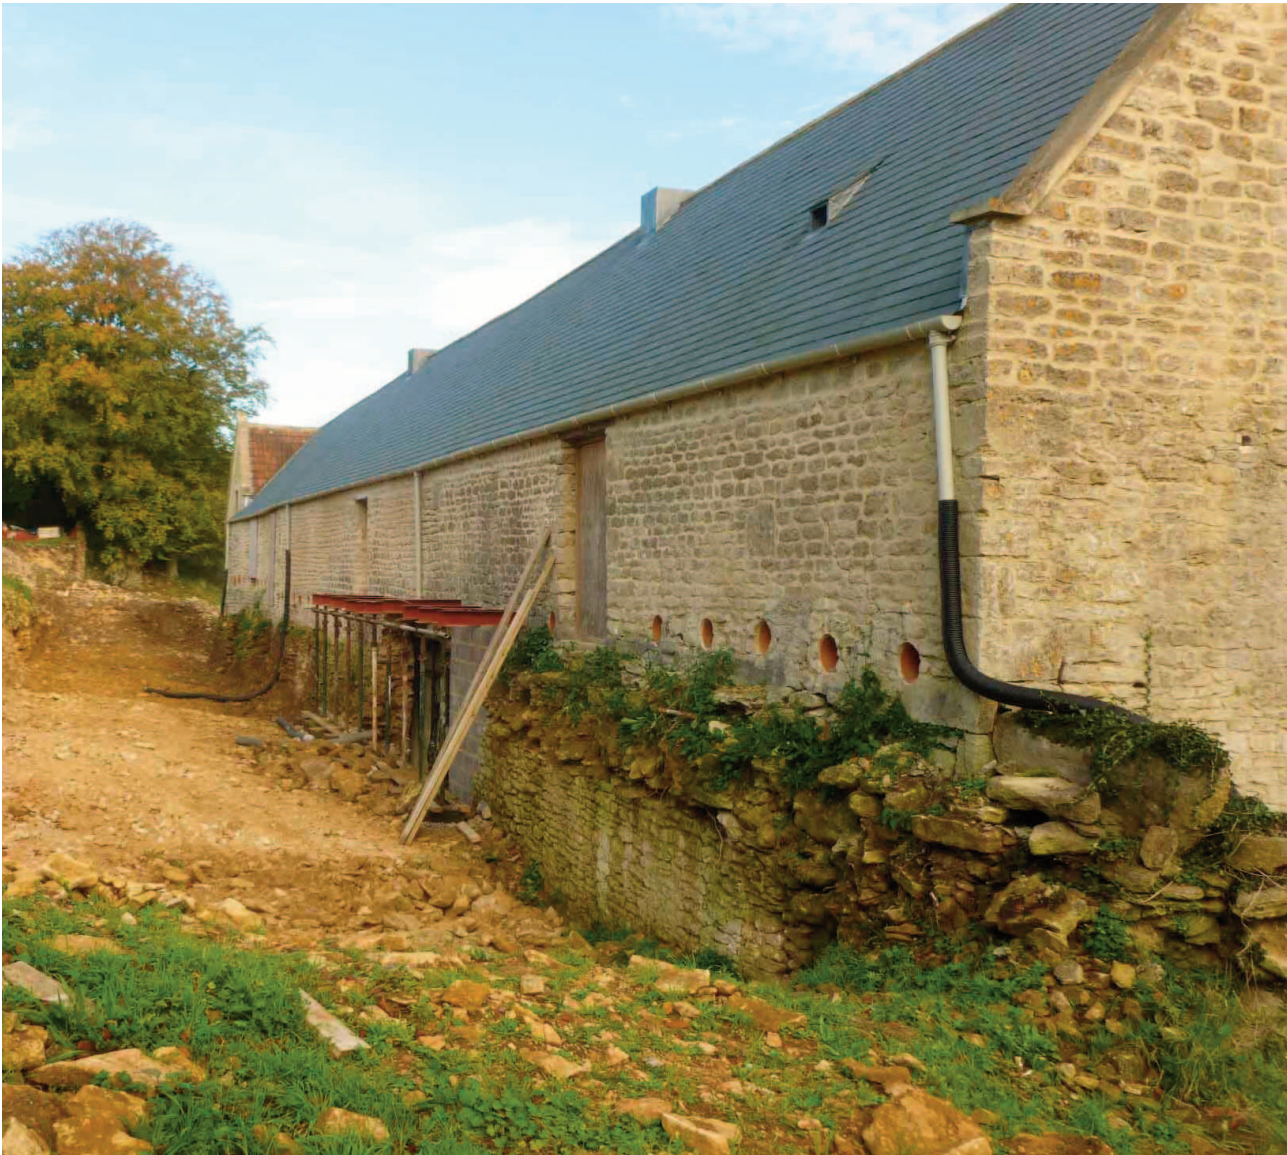
Fig. 22. The northwest wall of the barn following excavation for the 2m wide service trench and new retaining wall approved in 2016. This revealed that the southwest end of the wall was also seriously defective (as can be seen in this photograph) and this section was also rebuilt in faced blockwork to match the rest of this wall.

The southwest section of the rear wall proved to be in worse condition than anticipated, and in order to restore the structural integrity of the retained rear wall above ground level, the whole of the rear wall of the long barn below ground level has been rebuilt.

In the light of this information it is unsurprising that additional rebuilding was required once work commenced and as the photograph above shows the exposed wall was in parlous condition such that it would have been impractical to delay work on the west end of the wall once it had been exposed in order to ensure the safety of the remaining historic rear wall above ground level.

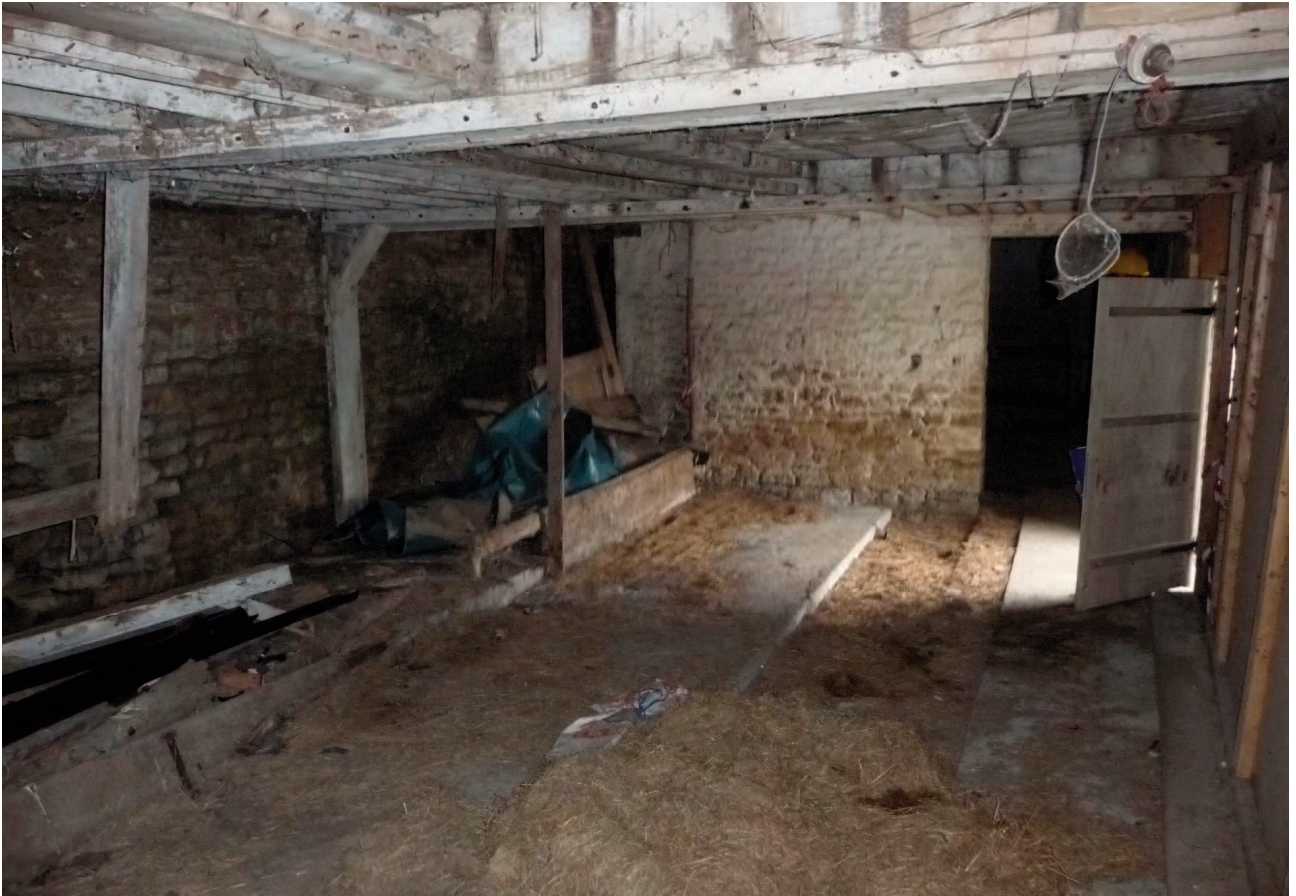
Fig. 23. The proposed dining room prior to commencement of the works with the rear retaining wall apparently in reasonable condition on the left. The first floor structure was in poor condition and approved for replacement in 2012.

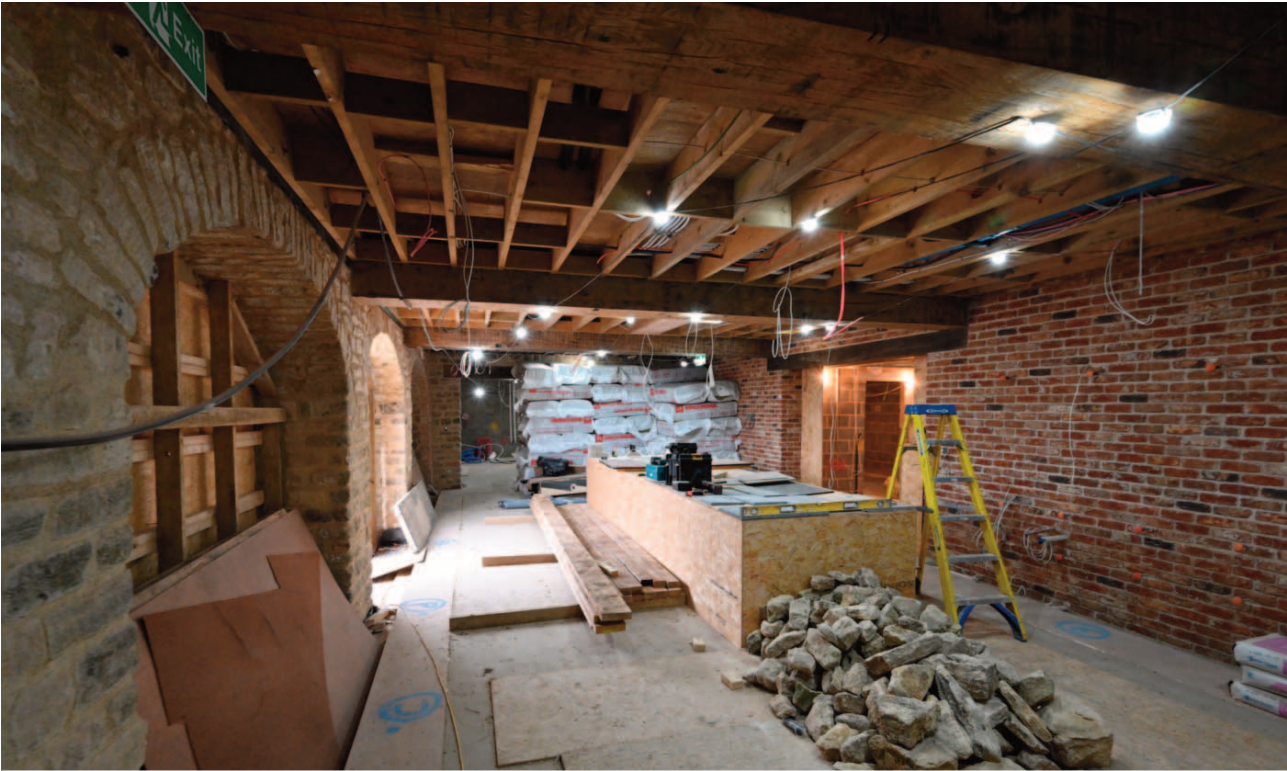
Fig. 24. The additional length of rebuilt ground floor rear wall in the new kitchen showing the new opening into the rear basement extension.. The extension walls and this section of rear rebuilt wall is faced in brick-work over blockwork.

The three new openings in the rebuilt rear wall provide access into the underground plant room, storage, rear kitchen and a small office. The smaller openings read as doorways with boarded doors and when closed they would read as appropriate for the former barn. The larger central opening be-

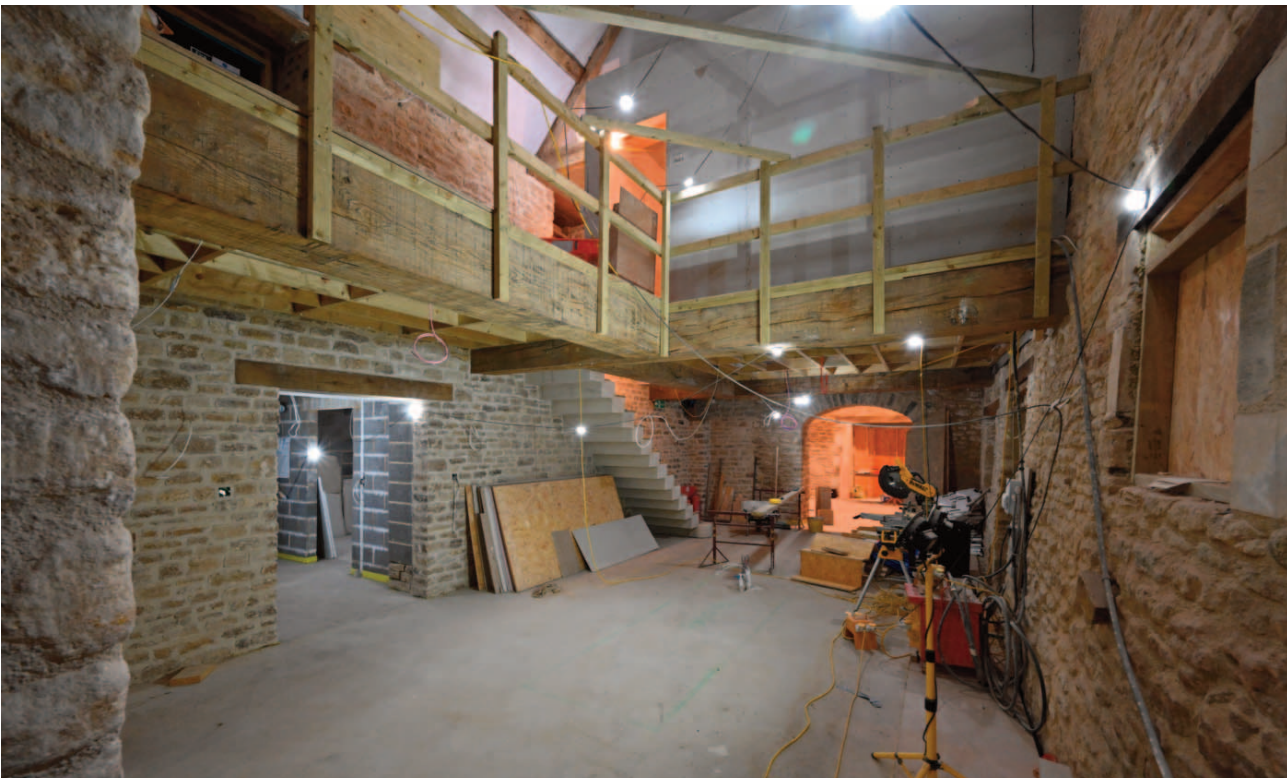
Fig. 25. The approved rebuilt rubblestone faced rear wall within the proposed dining room with the cross barn beyond. The new opening on the left opens into the new below ground extension

tween the kitchen within the barn and the rear basement kitchen will have greater visual impact emphasized by the surrounding brickwork within the largest room within this long range, however these changes have to be considered in the context of the approved residential conversion with this space with its previously approved series of ground floor fireplaces diminishing its former agricultural character. In this context it is hard to see how the use of brick lining to the modern rear wall together with this new opening in a rebuilt wall causes anything other than minor additional harm.

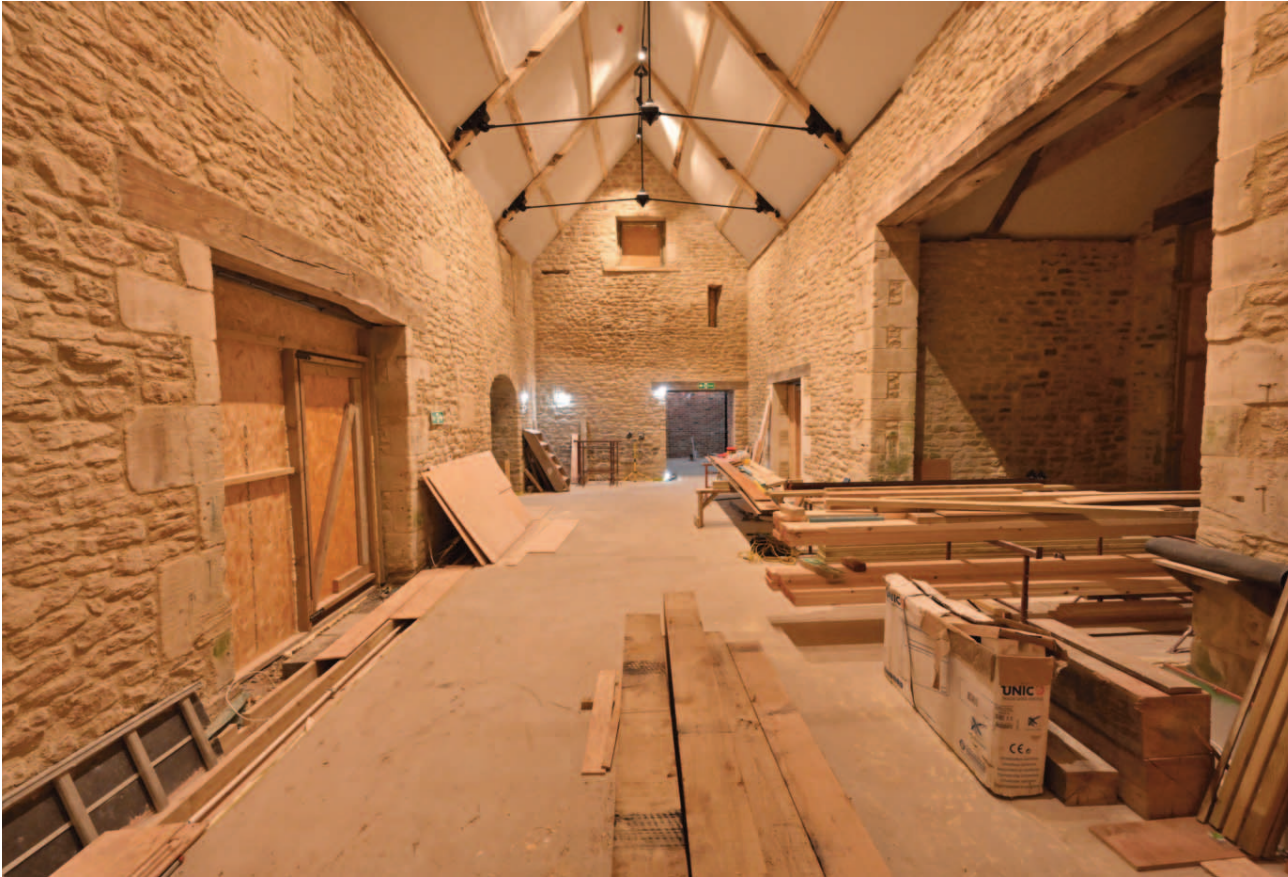
Fig. 26. The full height cross barn without the approved mezzanine and spiral stair at the far end. On the right beyond the midstrey is the new external door opening, and the slightly enlarged opening into the flat roofed rear extension in the far gable.

Within the cross barn, the approved mezzanine and spiral stair have been omitted opening up the entire space. In addition to the new external opening on the east elevation (described above), the previously-approved internal door into the new basement as been repositioned and widened slightly.
